**FINAL REPORT:
ON THE OWASCO LAKE HAB INHIBITING TECHNOLOGIES ASSESSMENT.**

**DANA HALL, PROJECT MANAGER
THE OWASCO WATERSHED LAKE ASSOCIATION**

John D. Halfman^{1,2,4}, Ileana Dumitriu^{3,4} & Lisa Cleckner^{2,4}

1/24/2019

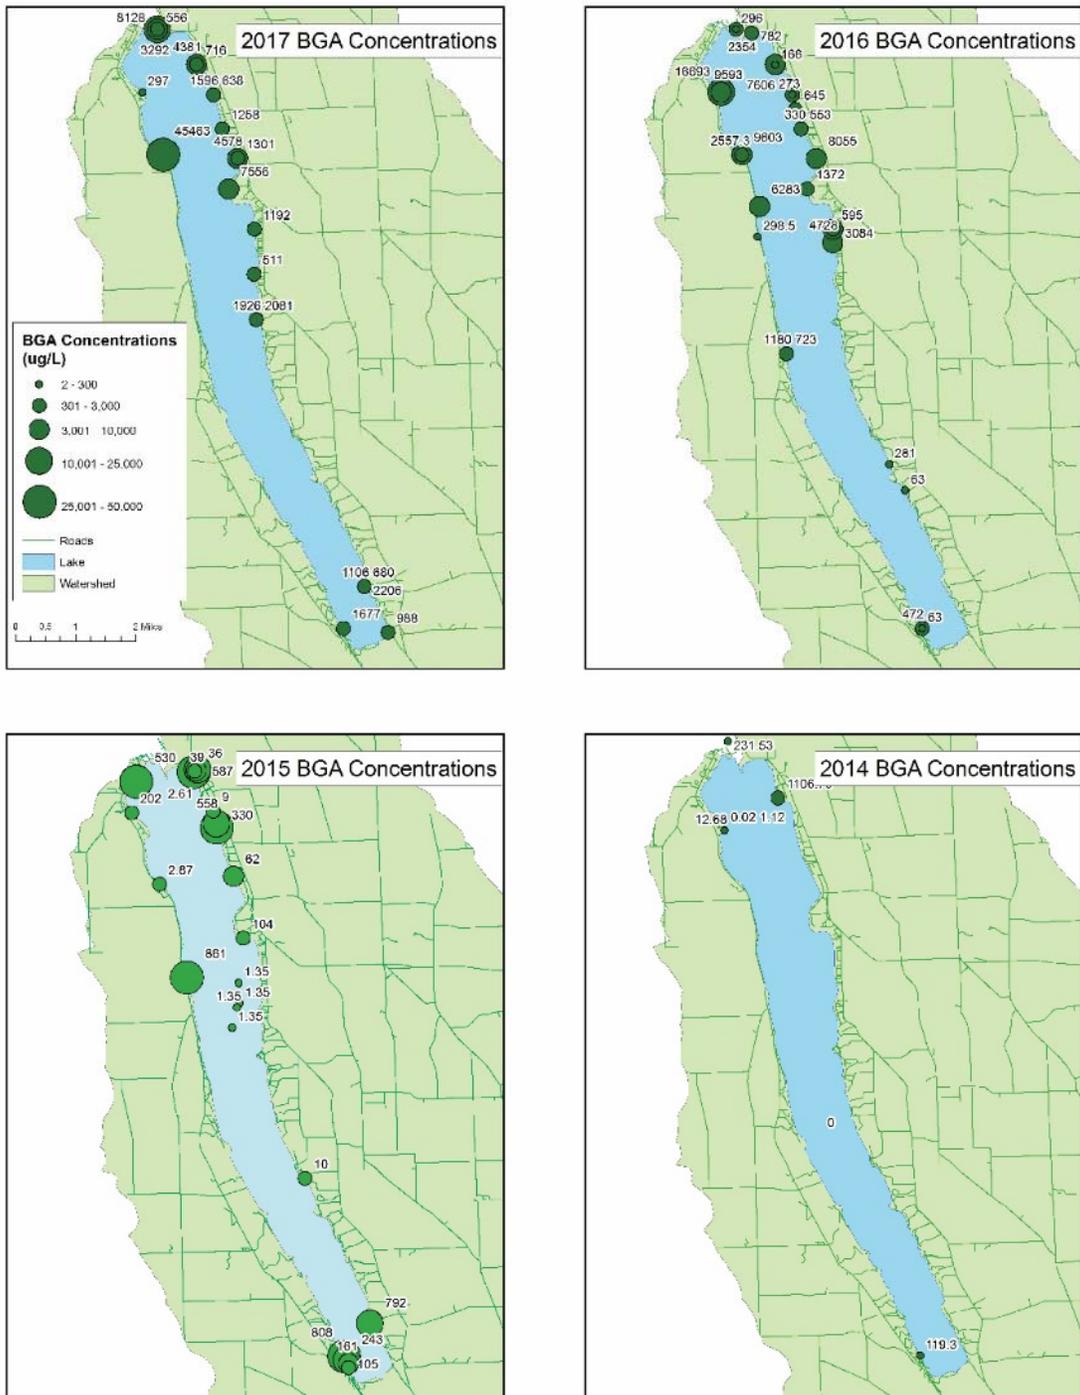
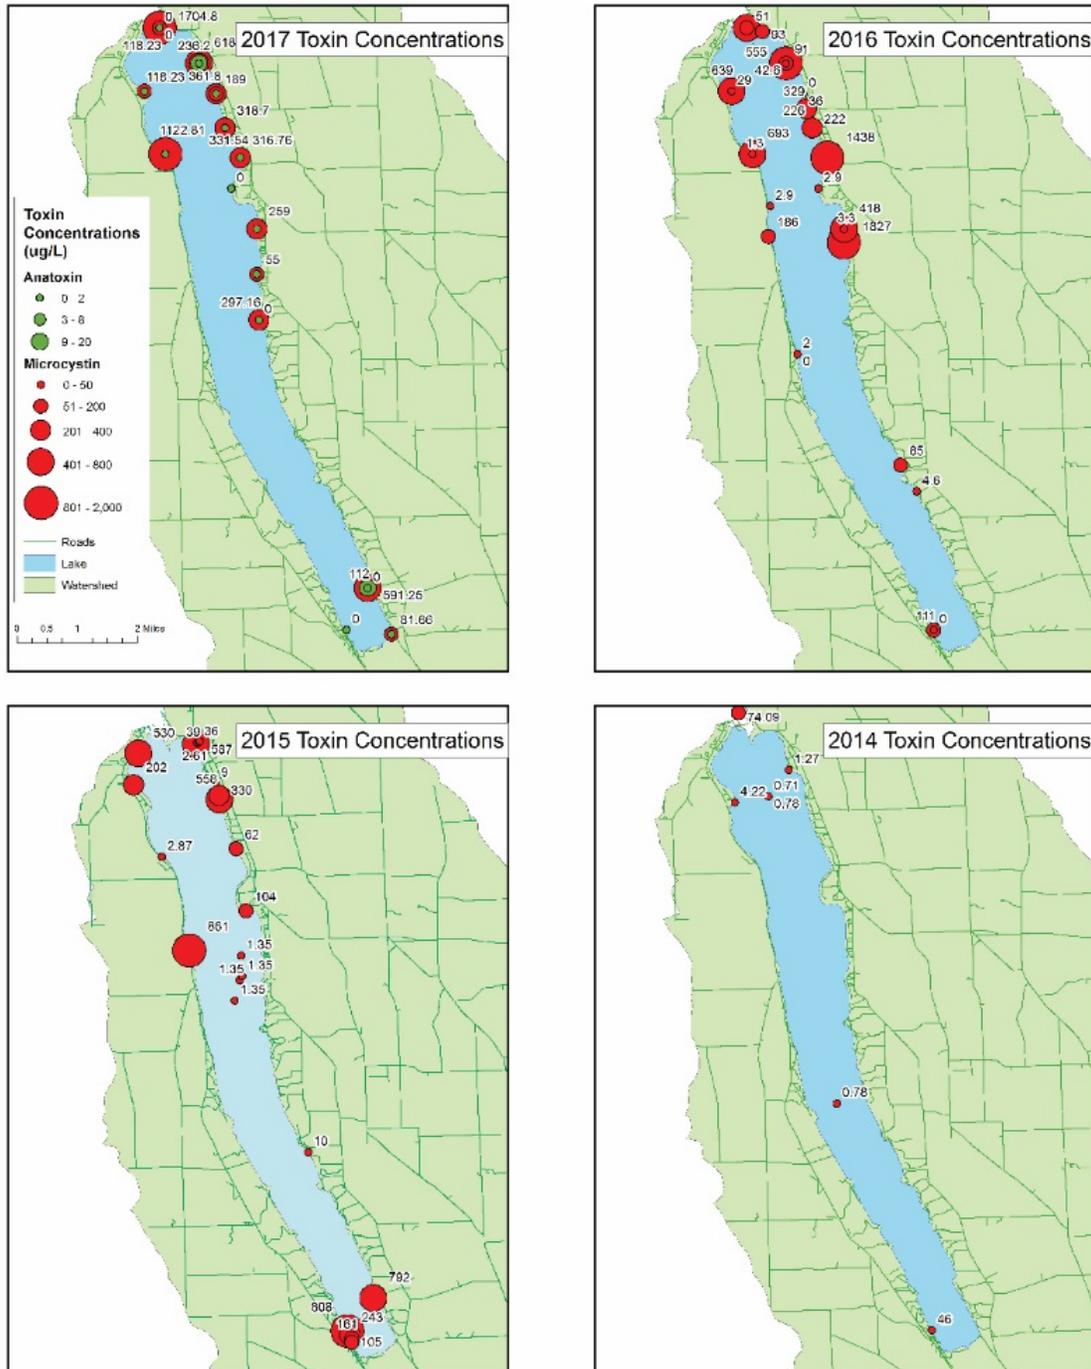
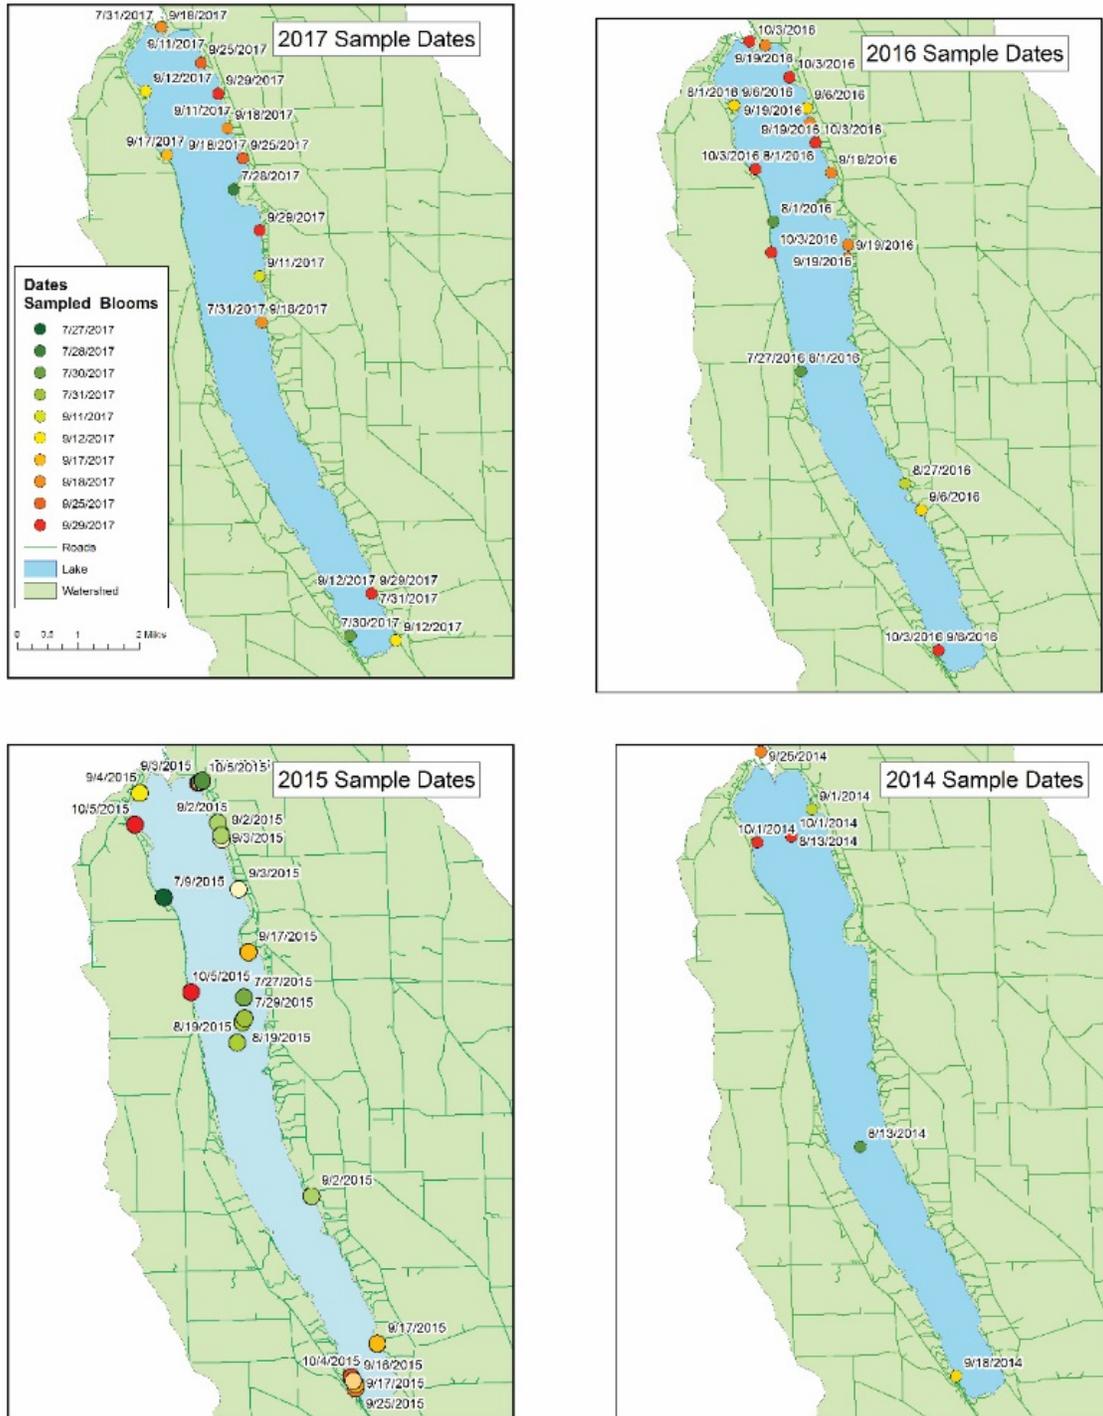
Fig. 1. Maps of the 2014 – 2017 shoreline BGA bloom dates, concentrations and microcystin and anatoxin (2017 only) toxin concentrations (Halfman et al, 2017a). Data by permission from the Owasco Lake Watershed Inspector & DEC.

Fig. 1 (cont). Maps of the 2014 – 2017 shoreline BGA bloom dates, concentrations and microcystin and anatoxin (2017 only) toxin concentrations (Halfman et al, 2017a). Data by permission from the Owasco Lake Watershed Inspector & DEC.

From 2014 through 2017, BGA blooms in Owasco Lake were detected primarily along the northeastern corner of the lake (Fig. 1, Halfman et al. 2017a). Measured BGA pigment concentrations ranged from 2 to over 10,000 µg/L with toxin concentrations from below detection to over 2,000 µg/L. Most of the blooms were concentrated along a shoreline. A few BGA events, however extended across the open lake. Many of the open lake accumulations of BGA were typically at concentrations below 25 µg/L so technically not a bloom. For reference, the NYSDEC defines a BGA bloom when the blue-green phycocyanin (chlorophyll unique to BGA) concentration exceeds 25 µg/L. A BGA bloom is reclassified as a bloom with high toxins when microcystin concentrations exceed 20 µg/L in nearshore areas and 10 µg/L in offshore areas. The EPA's drinking water guideline for microcystin is 0.3 µg/L for infants and 1.6 µg/L for school-age children and adults; and their recreational contact limit is 4 µg/L.

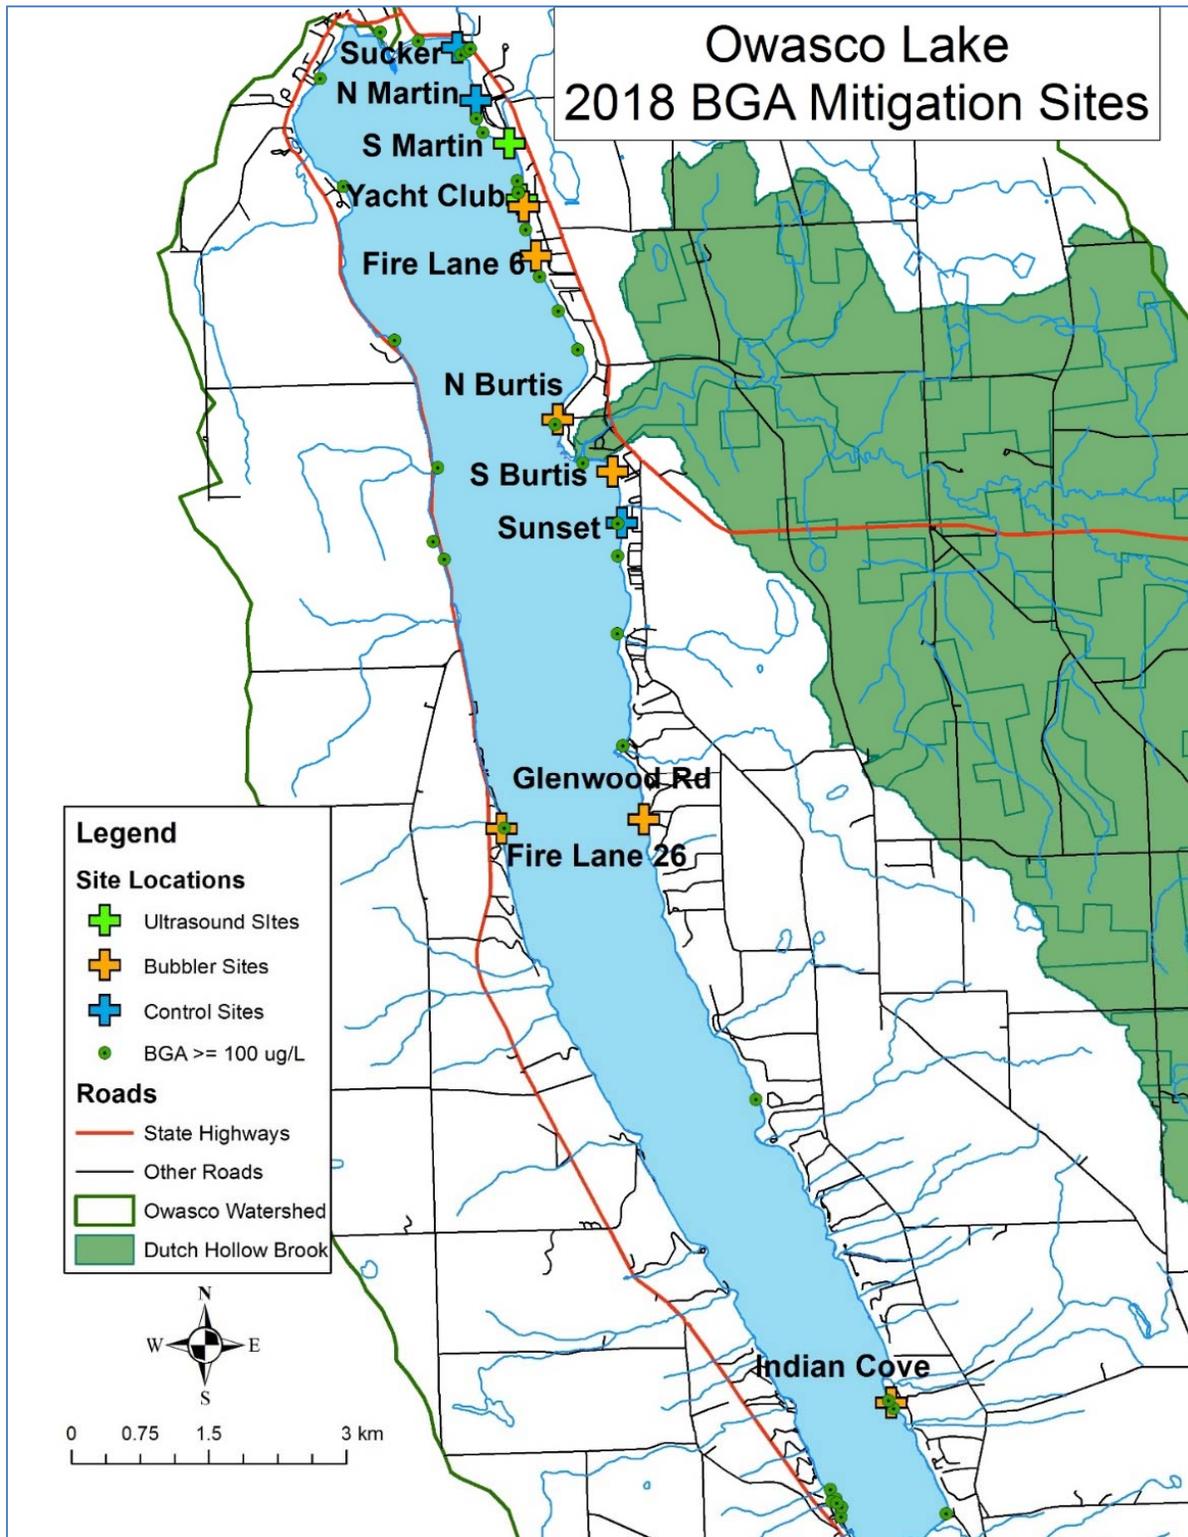
Fig. 2. Site locations (crosses) for the Owasco Lake HABs Inhibiting Technologies Assessment Project.

Eleven sites were selected around the lake with the majority along the northeast shoreline (Fig. 2, Table 1). These sites were jointly determined between Halfman and OWLA representatives. The site selection emphasized that each site must have experienced BGA blooms in the past. Unfortunately, the locations for the past blooms were identified by Survey Zone, where each zone spans up to a mile of the shoreline. Thus, the exact history for each site was not available. Two additional site selection criteria included the willingness of the homeowner to take daily photos, and provide access to their docks for water sampling.

Mitigation technologies were deployed at eight sites (Fig. 2, Table 1). A Quattro-DB ultrasonic device was deployed at two sites, the South Martin Swim Beach on South Martin Drive and the Owasco Yacht Club. Two Airmax PS20 (larger, noisier) or SW20 (smaller, quieter) air diffusing water column aerators were deployed at six sites, the Owasco Yacht Club, Fire Lane 6, N. Burtis, S. Burtis, Glenwood, Indian Cove and Fire Lane 26. The PS20 units were deployed at sites with deeper water adjacent to the shoreline. The SW20 is designed for water depths of 6 to 10 feet, and the PW20 is designed for waters as deep as 50 feet such as reservoirs and ponds; i.e., pond water aeration bubblers or “PW”. The distance between the device deployment and the sample location at each site were always within the manufacturer’s estimated impact range for the device used at that site. Three sites, Sucker, N. Martin and Sunset, had no mitigation technologies installed and served as experimental “control” sites.

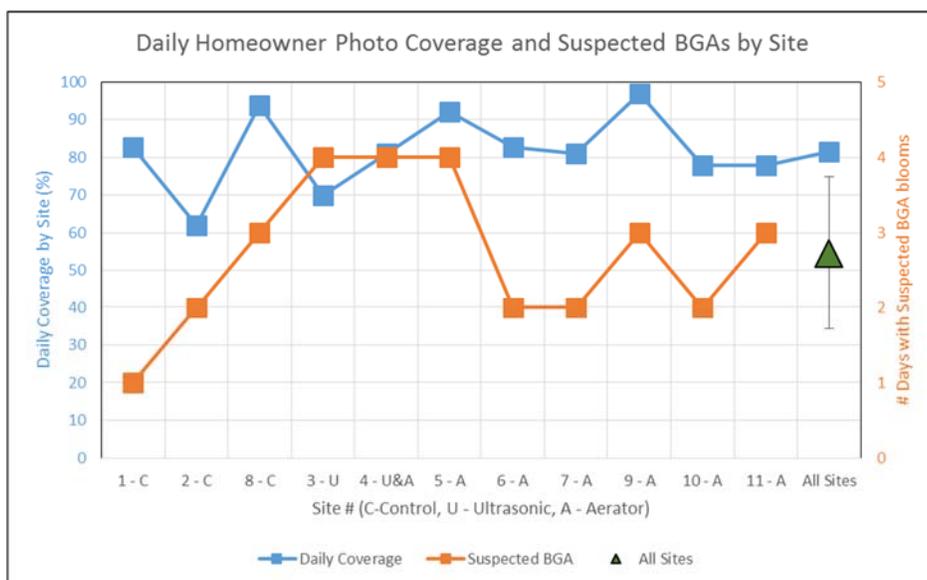
Fig. 3. The complete record of daily homeowner photographs (above). The percentage of days photos were taken, submitted and catalogued at each site, and the number of days blooms were suspected in the photographs (below). The green triangle, lower plot on right side, is the all site detected suspected bloom mean ($\pm 1\sigma$ standard deviation).

Homeowner Photos: The daily homeowner photographs provided the most frequent record of BGA blooms (Fig. 3). The daily submission rate at each site ranged from 62 to 97%, and averaged 82% of the time during the 63 day survey (Fig. 3). Their submission rate is very high for a volunteer workforce, and underlies the remarkable dedication of each homeowner to this project and more importantly the health and wellbeing of Owasco Lake. Only six of the 128 missing photos were from days when other sites detected blooms, thus minimizing but not eliminating the bloom detection impact of the missing photos. Some homeowners submitted more than one photo on days with a bloom.

Spatially, the number of suspected blooms imaged at each site ranged from one to four days during the study (Fig. 3). The mean number of suspected blooms was 2.7 days. Temporally, blooms were detected at one or more sites on eight different days during the study. The dates when at least one site detected a bloom (with the number of sites reporting a suspected bloom in parentheses) were 8-15 (1), 8-16 (5), 8-21 (4), 9-4 (6), 9-12 (6), 9-13 (4), 9-14 (2), and 9-16 (2).

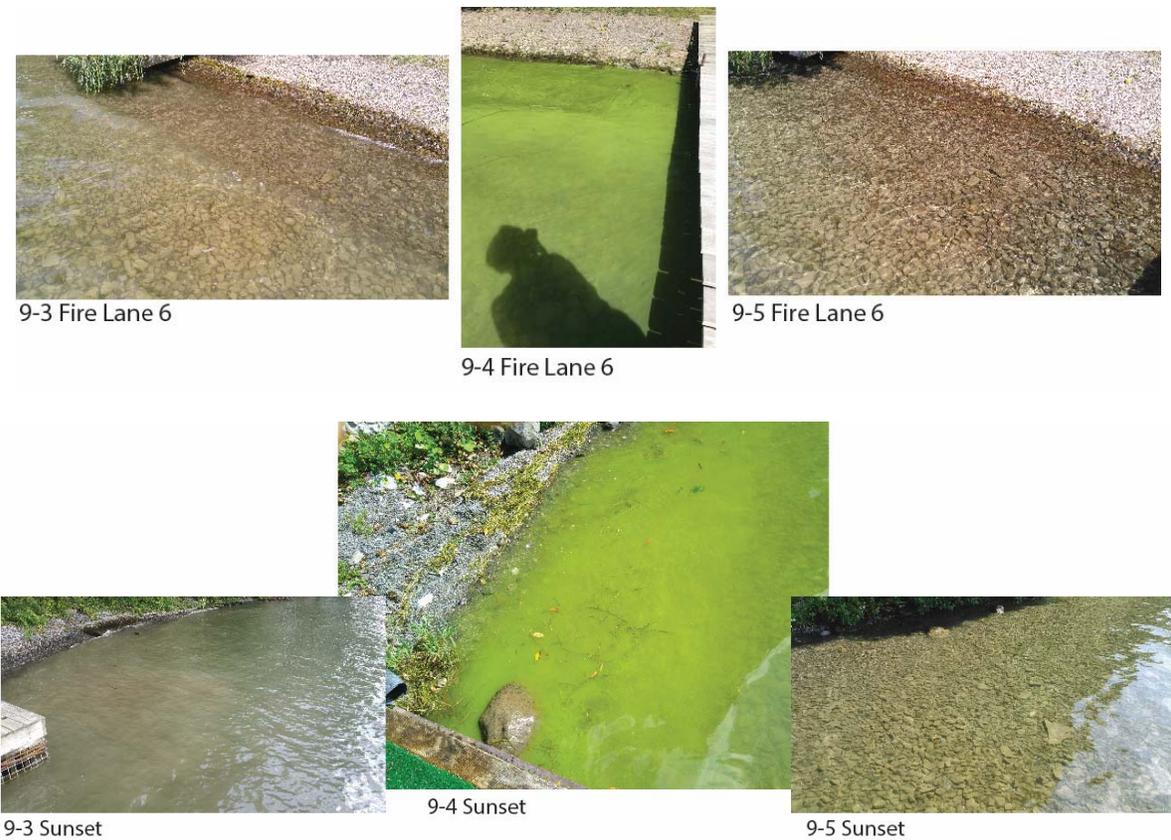
Fig. 4. Example homeowner images of a significant BGA bloom on 9-4, sandwiched between no blooms on the preceding (9-3) and following (9-5) days.

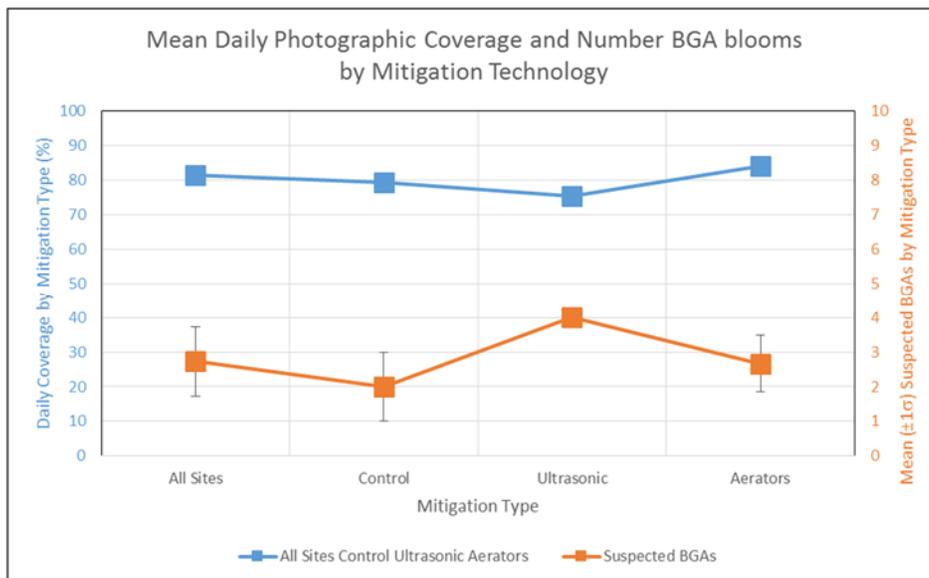
Fig. 5. The mean daily photographic coverage (blue) and the average number blooms (orange $\pm 1\sigma$) by site type.

The number of blooms detected at each site, on first analysis, does not support a successful test of the mitigation technologies. The smallest number of blooms were detected at Sucker, a “control” site, and the largest number of blooms were detected at three mitigation sites, S Martin, the Yacht Club, and Fire Lane 6, where an Ultrasonic device, an Ultrasonic device and Aerator bubbler, & Aerator bubblers, respectively, were deployed. Averaging the available data for each type of site, the “control” sites appeared to experience the fewest blooms and the ultrasonic device sites experienced the most blooms, but the variability is small (means within $\pm 1\sigma$ standard deviation), thus these averages were statically indistinguishable from each other (Fig. 5).

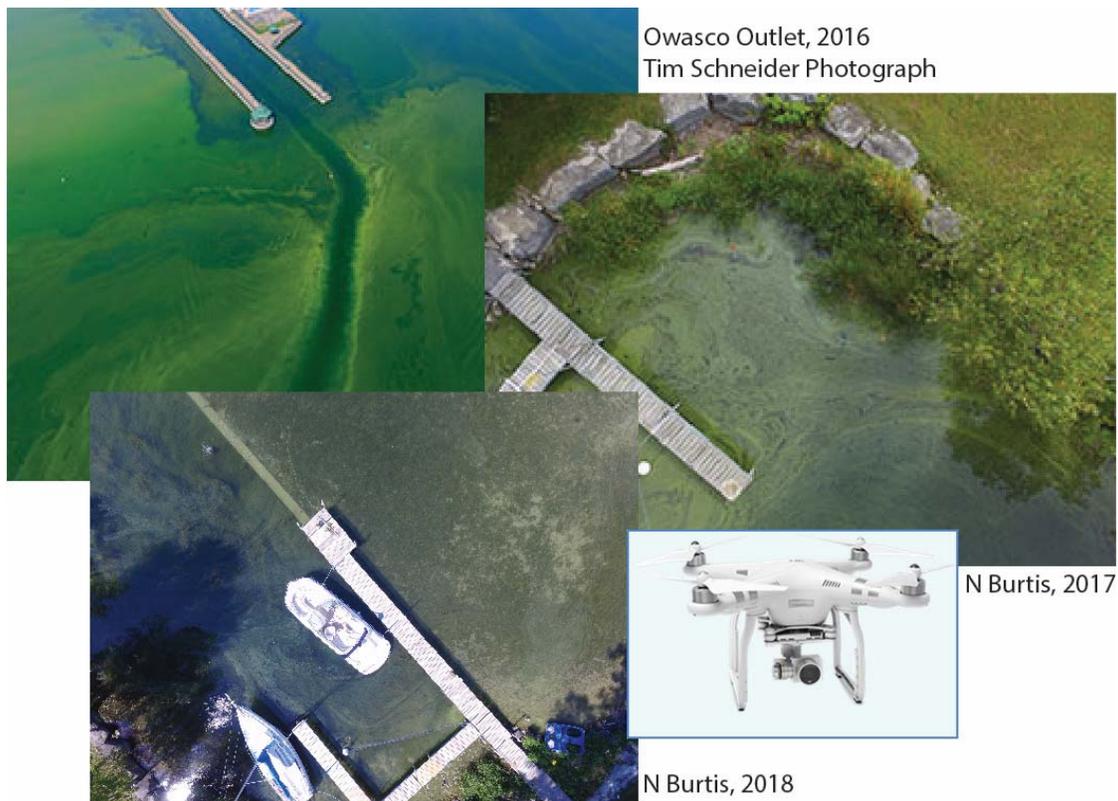
Fig. 6. Drone images of significant BGA blooms from previous years (above) and no bloom during 2018 (below), conclusions confirmed by water samples. The bottom and top right-hand images were from the identical site. The intensity of the green in the earlier images greatly exceeds the worse bloom imaged by drone in 2018.

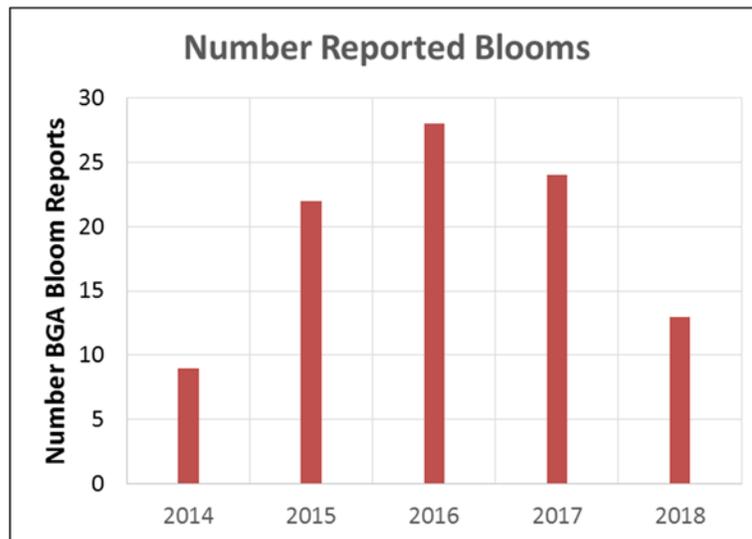
Fig. 7. Number of blooms detected in Owasco Lake from 2014 - 2018 by the HABs Surveillance team.

The HABs Shoreline Surveillance team also detected fewer confirmed blooms in 2018 than in earlier years (Fig. 7). For example, weekly site visits at N Burtis consistently detected blooms in 2017 but this site rarely had blooms in 2018. A decreased presence of BGA was also highlighted in the drone images from 2018 compared to earlier years. Two example images from N Burtis point are shown for comparison (Fig. 6). One may argue that the lower frequency of blooms at N Burtis was due to the aerator mitigation. However, the lower frequency of blooms was lake wide and not just at the mitigation sites. The lack of blooms around the lake and similar results between the "controls" and the mitigation sites in every parameter made it impossible to assess the technologies. Perhaps this study should be repeated when blooms are more prevalent around the lake.

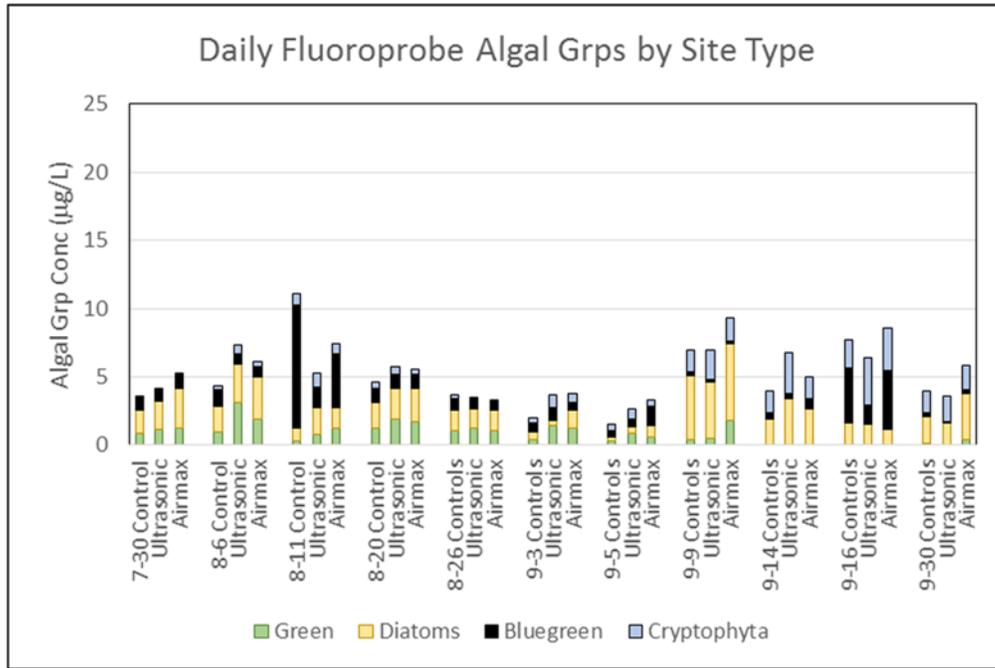
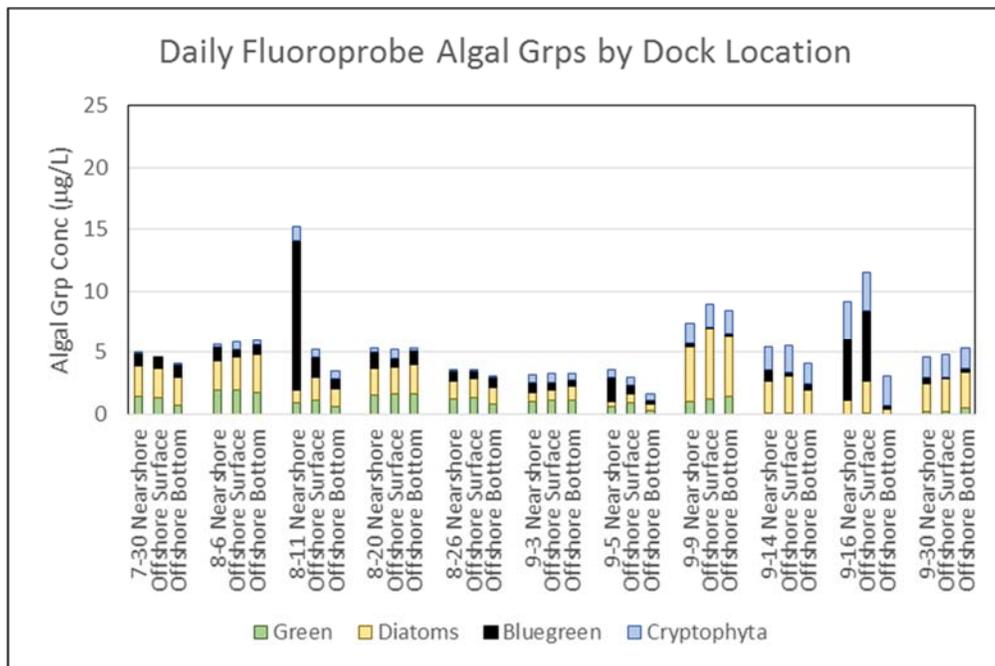
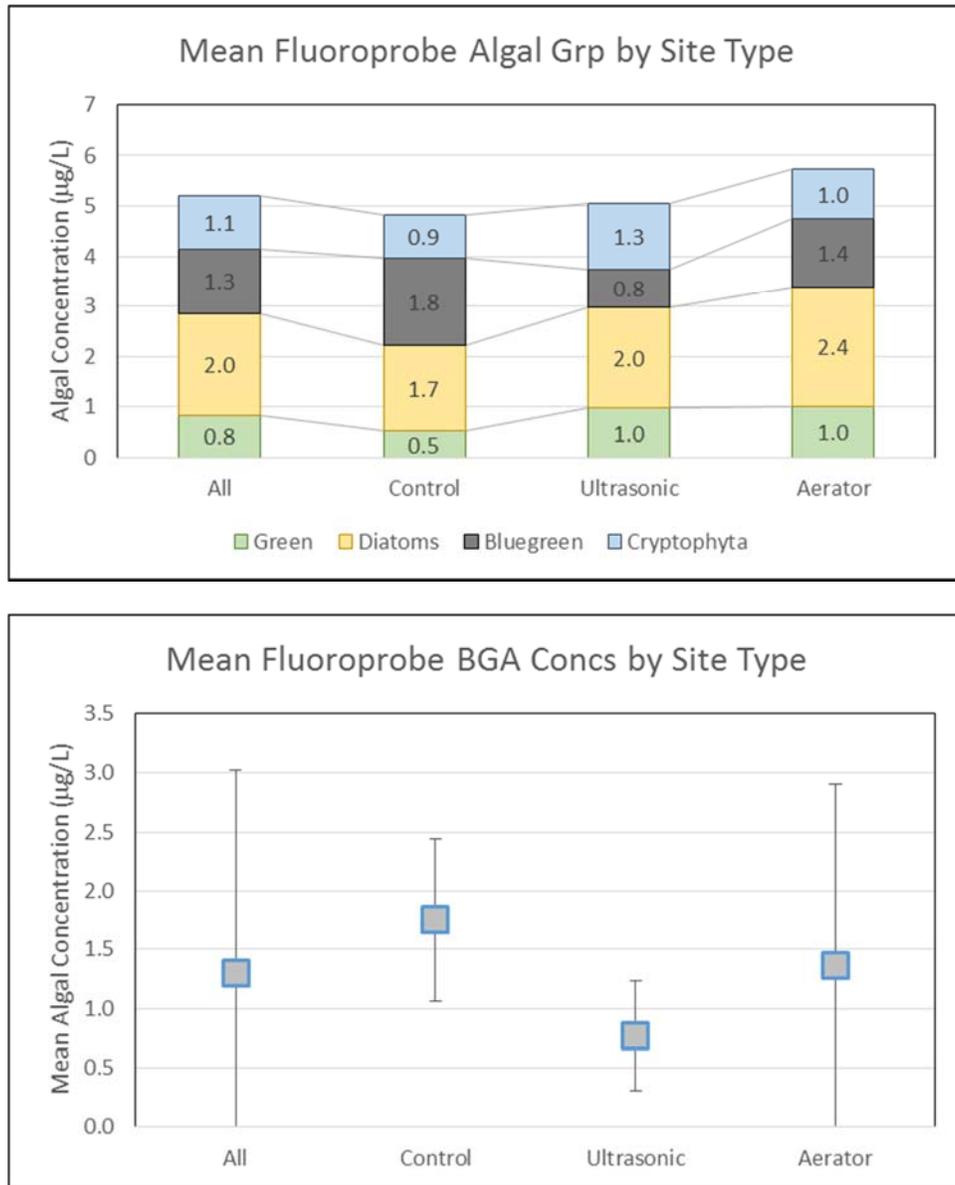
Fig. 8. Daily mean bbe FluoroProbe results, averaged by mitigation type (above), dock location (middle top), survey mean bbe FluoroProbe results for all samples (middle bottom), and survey mean BGA concentrations by site type (bottom, $\pm 1\sigma$).

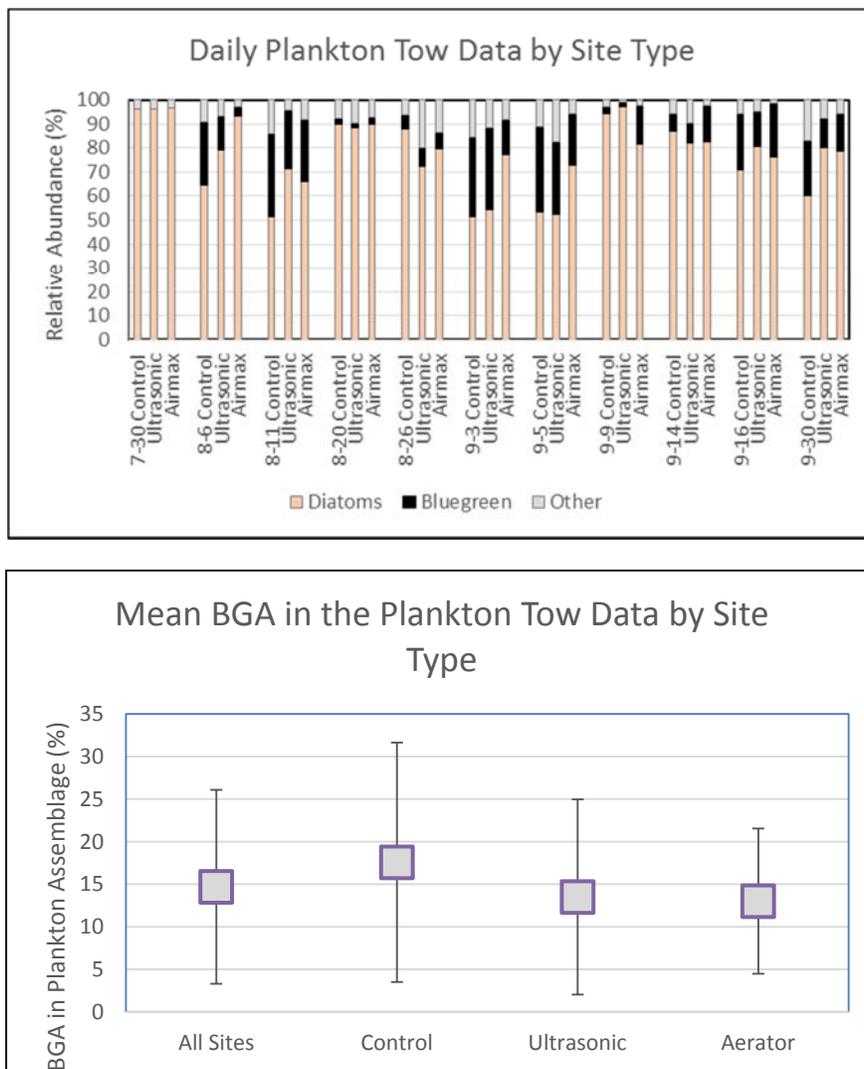
Fig. 9. Above daily mean plankton assemblage data from the plankton tows, averaged by mitigation type. Below survey mean BGA from the plankton tows ($\pm 1\sigma$).

Even though the daily mean BGA relative percentage was larger at the “control” sites than the mitigation sites, i.e., 17.6 vs. 13.5 and 13.0 (Fig. 9) and suggests that the mitigation technologies were successful, this is not the case. The survey mean BGA percentages by mitigation type, were again statistically indistinguishable ($\pm 1\sigma$ standard deviation) and preclude any conclusion.

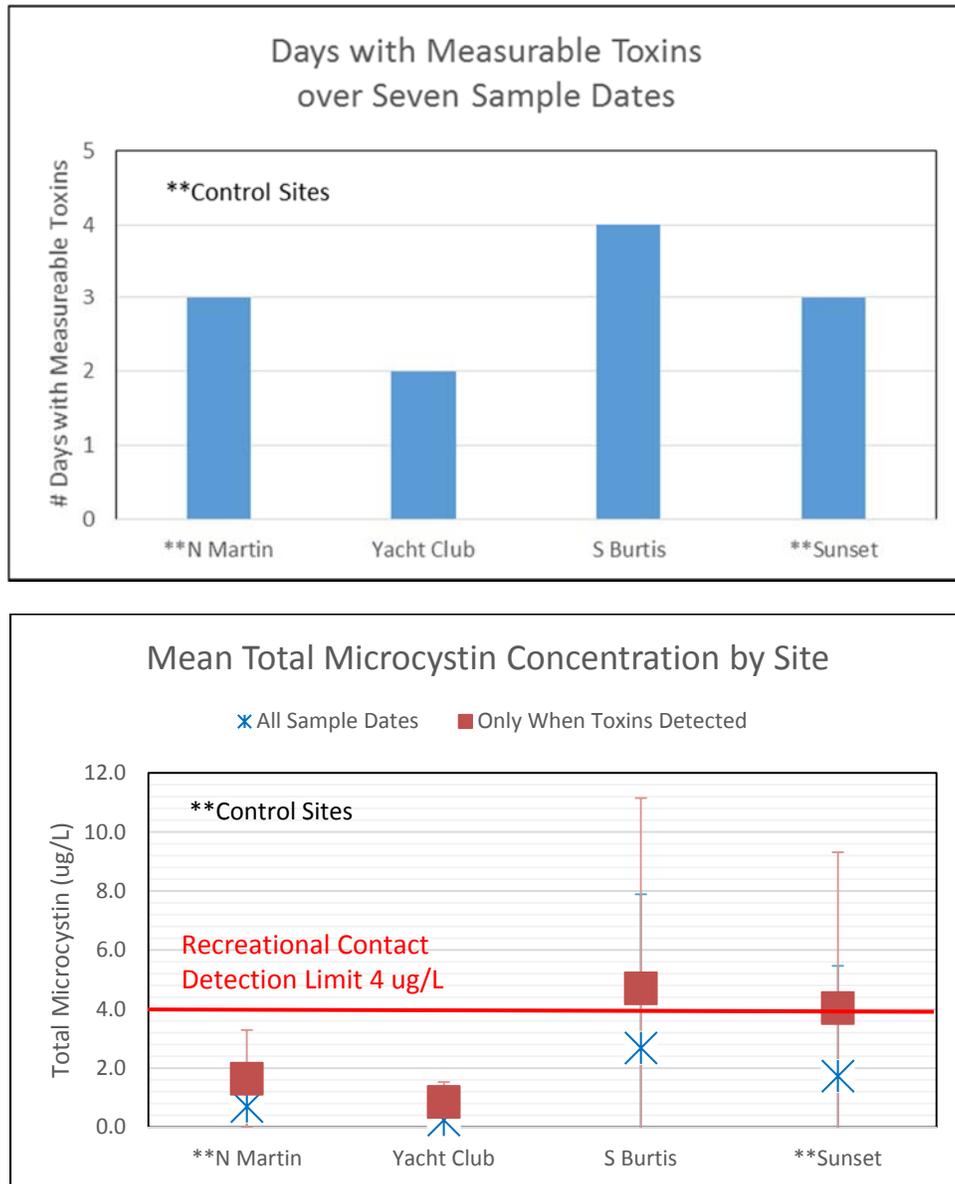
Fig. 10. Days with measurable toxins (above), and toxin concentrations averaged by site type ($\pm 1\sigma$, below).

Five samples had toxin concentrations above 1 µg/L (Fig. 10). The sample on 9-5 at S Burtis had a concentration of 4 µg/L. The other three sites did not detect toxins on this date. On 9-16, above background concentrations were detected at the Yacht Club, N Martin, Sunset and S

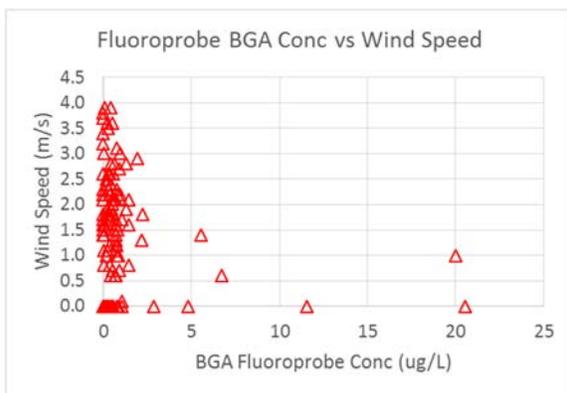
Fig. 13a. Wind speeds vs. FluoroProbe BGA concentrations that indicate that even gentle winds (>1.5 m/s) appear to limit BGA accumulations.

Wind Speed, Wind Direction, Air & Water Temperatures: Dock-side wind speeds ranged from 0 to 3.9 m/s (~8 mph), and averaged 1.6 m/s on the survey dates. Appendix D (wind) & E (temperature) tabulates the raw data. The strongest winds were detected on 9-30, and the weakest winds on 9-16. Wind speed appears to impact FluoroProbe BGA concentrations. BGA concentrations never exceeded 1.5 mg/L, and averaged 0.5 mg/L, when wind speeds at the docks exceeded 1.5 m/s (3.5 mph, Fig. 13a).

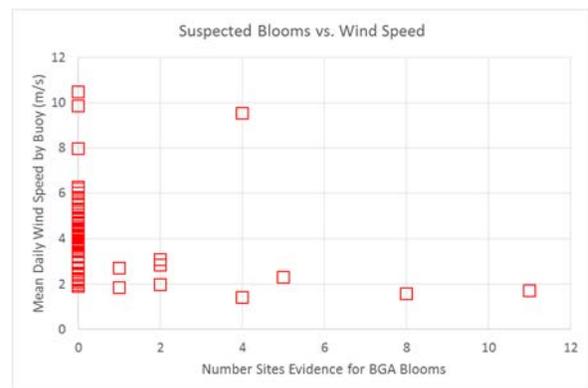
Fig. 13b. Buoy mean daily wind speed vs. suspected blooms detected in the homeowner photographs. Again, BGA accumulations are restricted to calm weather except on 8-21.

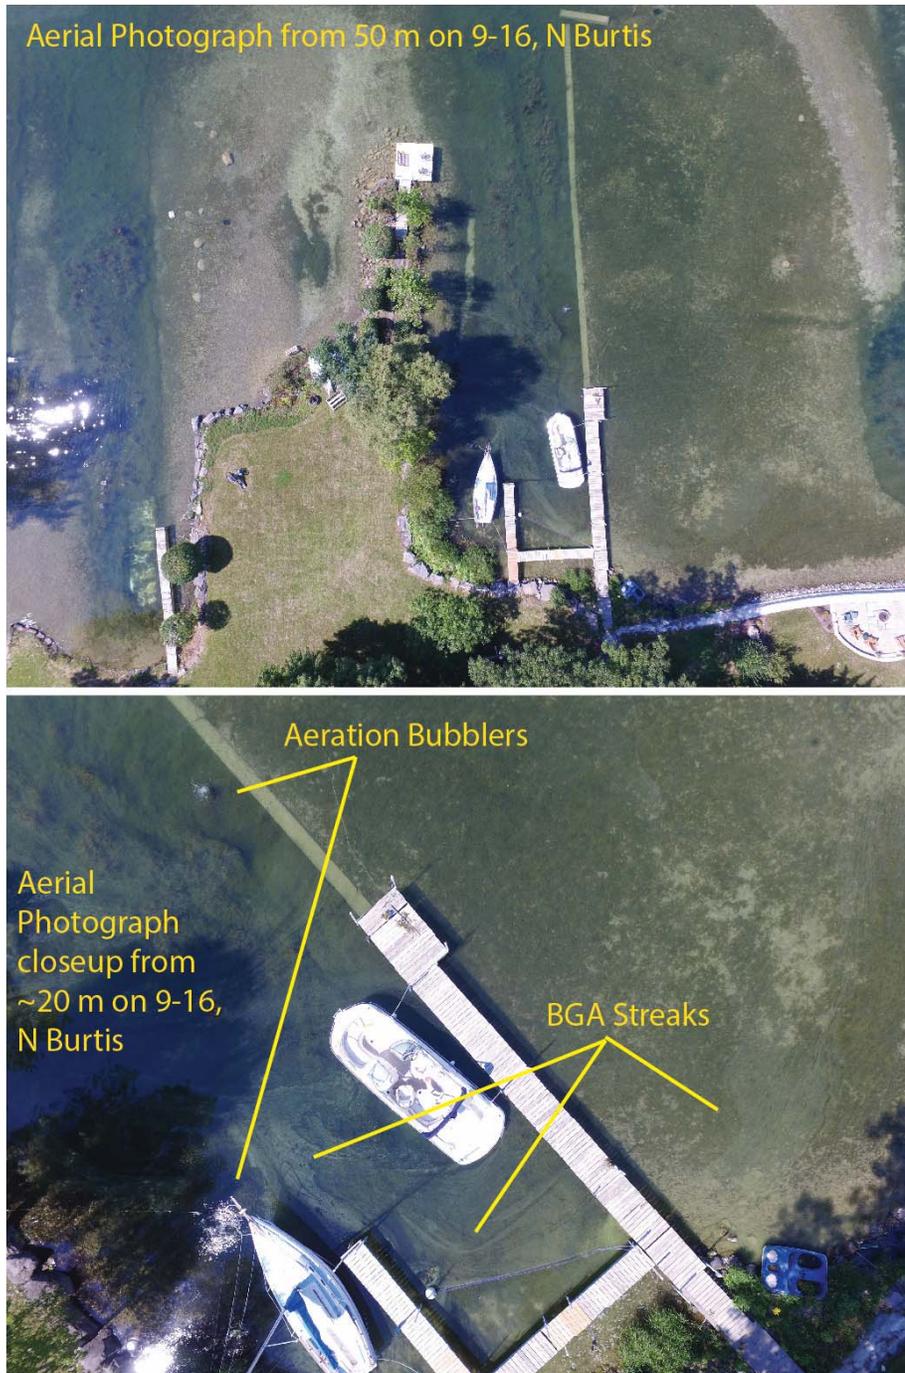
Fig. 11. Streaks of BGA at the N Burtis site from 50 and 20 m above the lake surface.

Aerial Drone Images: Visual inspection of the drone images identified only a few dates with BGA (Fig. 11). For example, BGA were detected at the surface of the lake at N Burtis on 9-16 when surface BGA concentrations were measured at 16 and 20 µg/L. Streaks of accumulating BGA were observed surrounding the boats and dock at this site. Perhaps the BGA were pushed by the waves resulting from the rocking boats. BGA surface accumulations were not visually detected in the majority of the images, a finding consistent with the sample analyses. We suggest that the BGA were not concentrated enough and/or their distributions were too uniform in the images for visual discrimination. We are still working on algorithms to calculate the concentration of algae based on the image data.

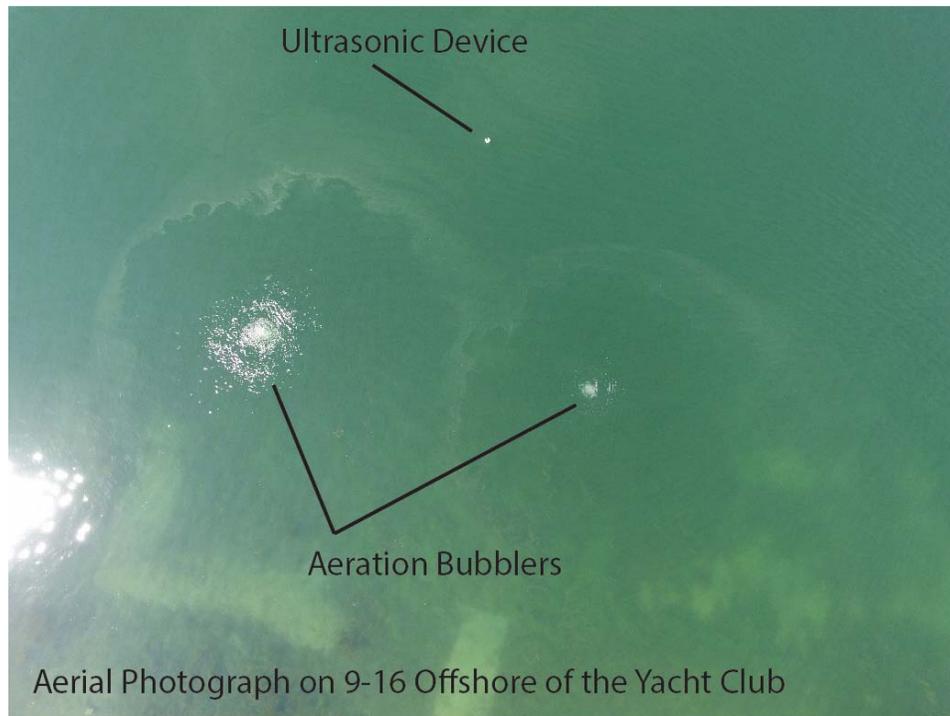
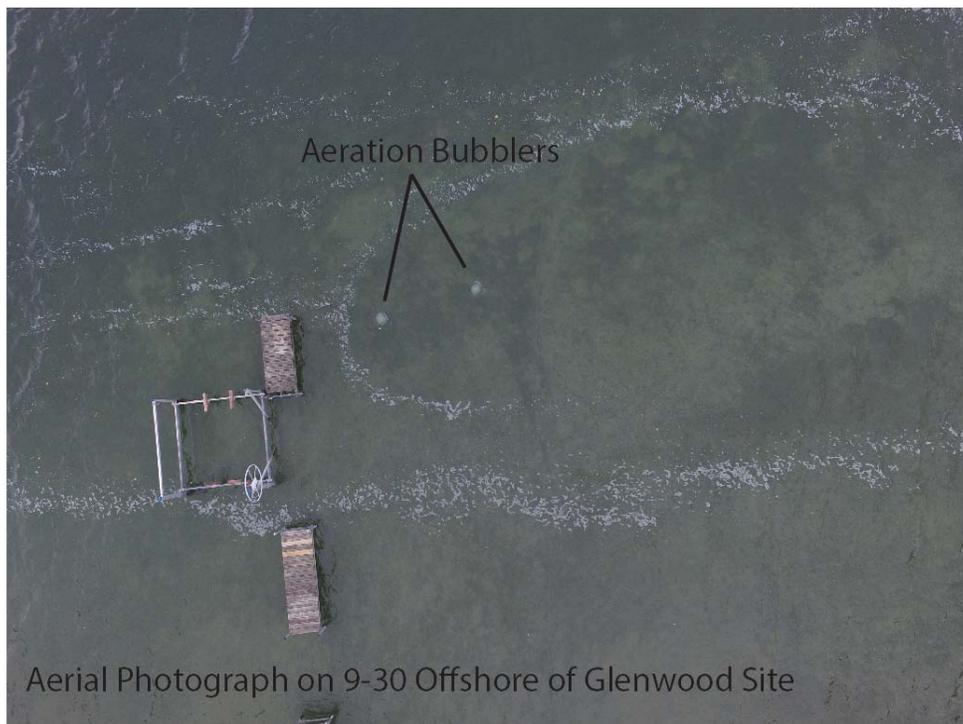
Fig. 12. BGA circles and white-foam streaks displaced around the aeration bubbles at the Yacht Club (above) and Glenwood (below) sites. It suggests that the aeration bubbler devices push surface accumulations of materials up to ~30 meters (~100 ft) away from the bubbles, even on windy days.

The ring formation and their 30 m, i.e., limited, diameters introduces an interesting question. Did the mitigation technologies have a greater impact at some locations because they were deployed closer to the dock where samples were collected? Three aerator sites, N Burtis, S Burtis and Indian Cove, detected only two days of BGA blooms compared to three or more suspected blooms at the other mitigation sites. The aerators at these three sites were positioned at or very close to the docks compared to the other mitigation sites. The ultrasonic devices at S Martin and the Yacht Club were deployed farther away from the sample docks than any of the aeration bubblers, and these two sites along with one aerator site (Fire Lane 6) experienced the largest number of blooms. This speculation however is tentative at this time because separation between the most (4) and least (1) number of blooms is very small, and may be subject to other factors like missed blooms at any of the sites, and other issues with deploying ultrasonic devices in shallow water identified above. Similar rings were not detected around the ultrasonic devices (Fig. 12). It suggests that a BGA sensor string should be deployed at each device extending at along surface from the device to open water and/or towards shore, and vertically in the water column at the device to quantify the concentration and displacement distances in the future.

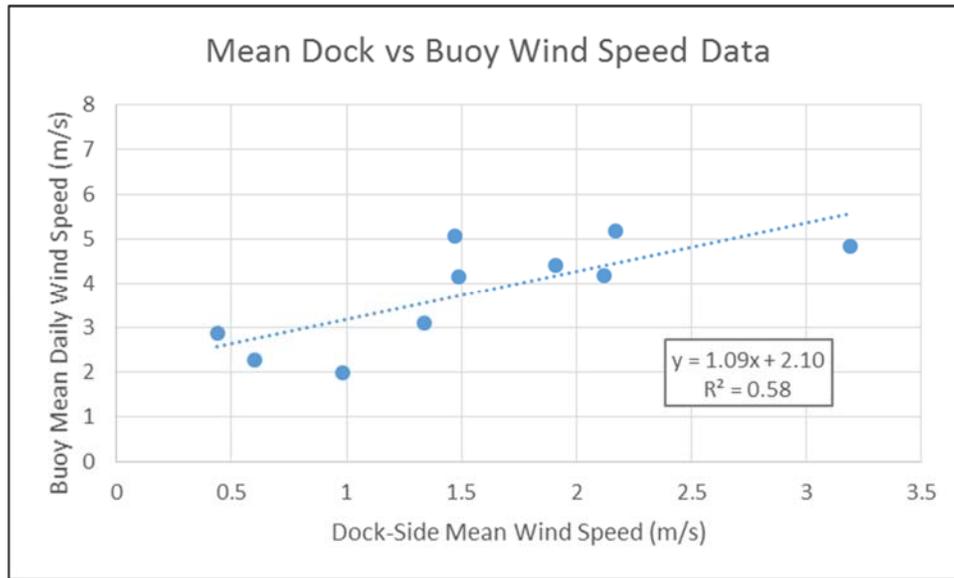
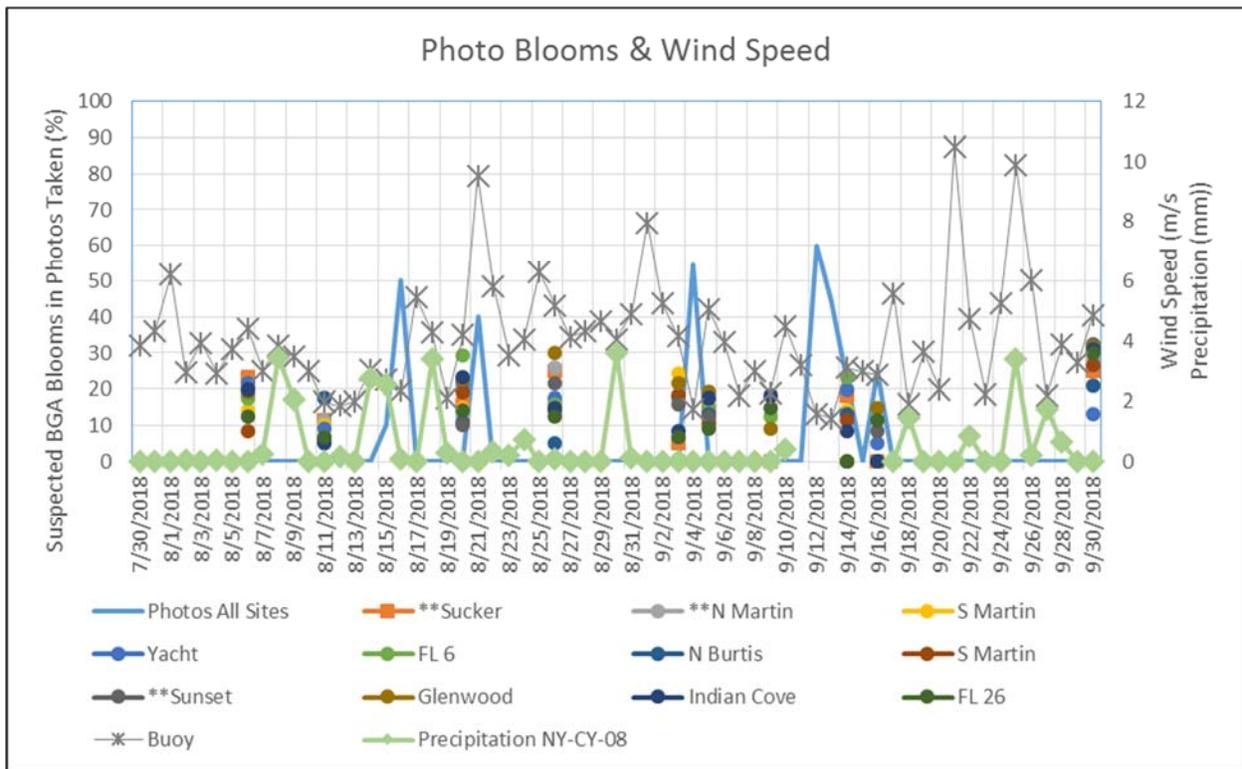
Fig. 14. Wind speed detected at the FLI monitoring buoy weakly correlated to the dockside measurements (above). Wind speeds vs the homeowner record of suspected blooms (below). It appears that more blooms were detected on calmer days just after rain events.
