**FINAL REPORT:
ON THE OWASCO LAKE HAB INHIBITING TECHNOLOGIES ASSESSMENT.**

**DANA HALL, PROJECT MANAGER
THE OWASCO WATERSHED LAKE ASSOCIATION**

John D. Halfman^{1,2,4}, Ileana Dumitriu^{3,4} & Lisa Cleckner^{2,4}

1/24/2019

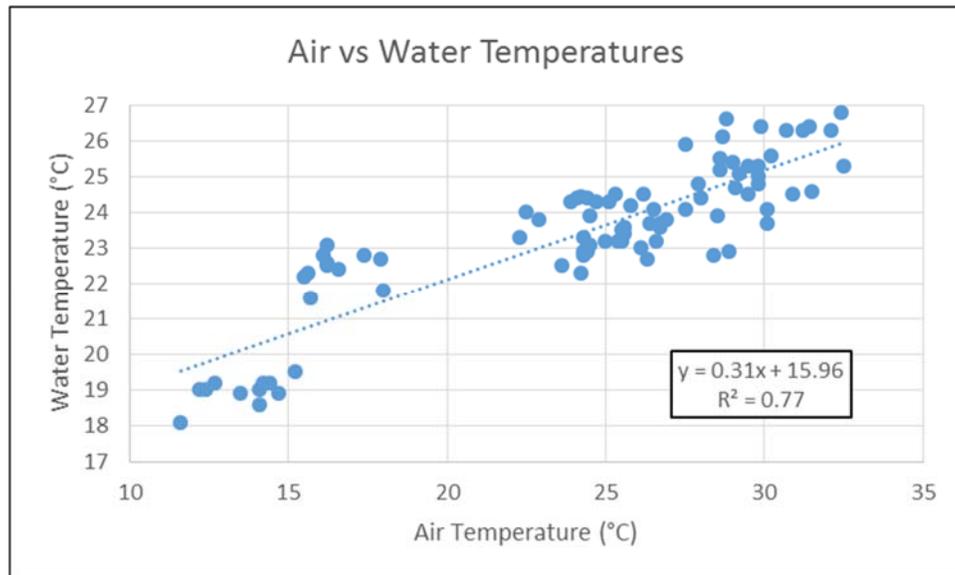
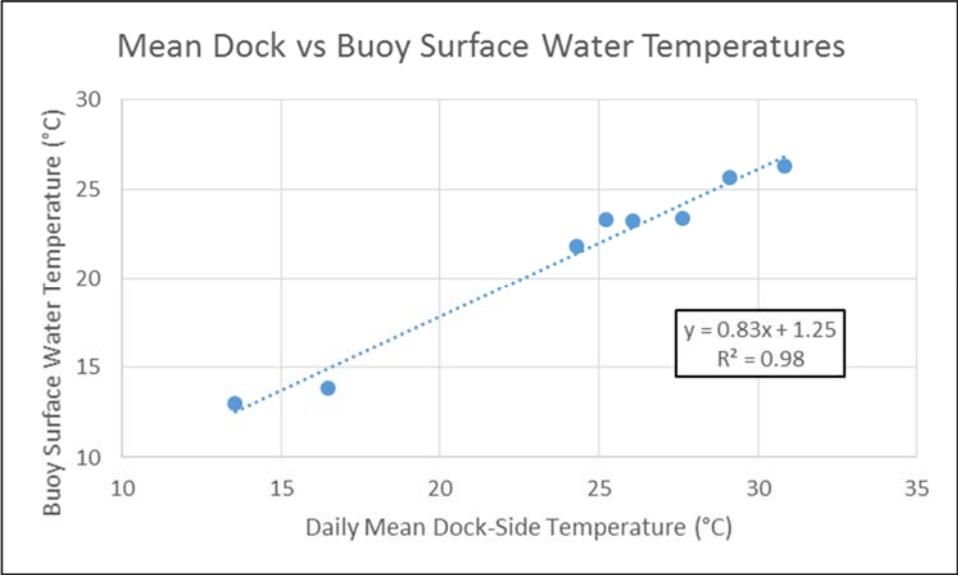
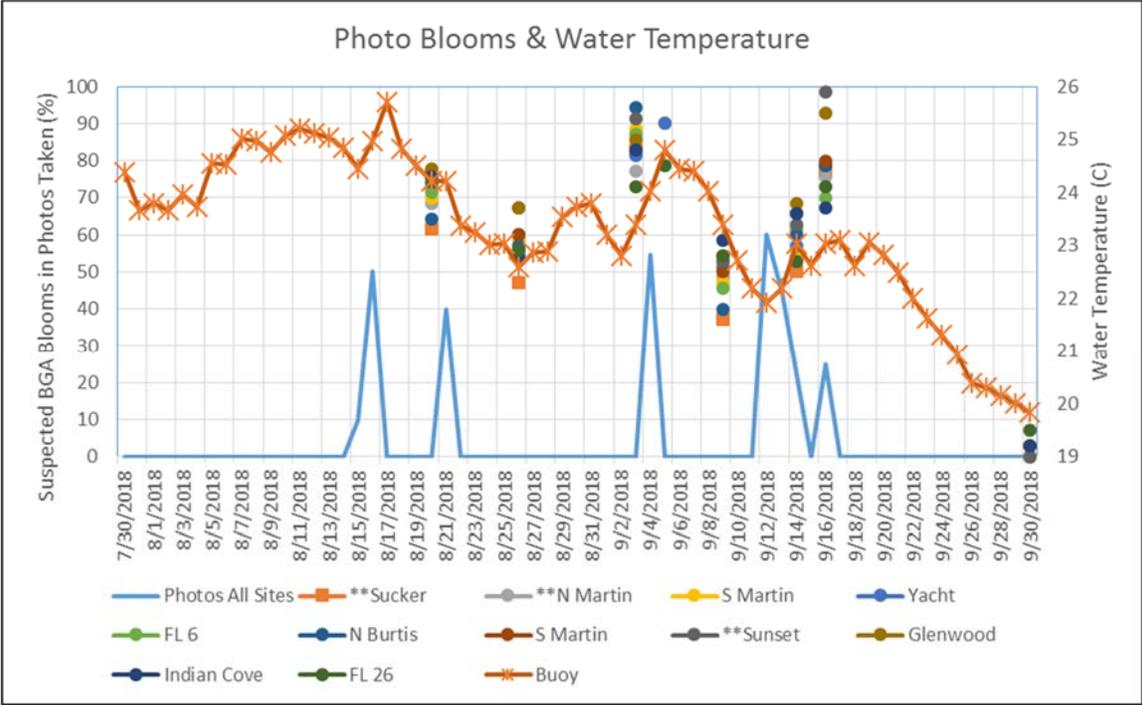
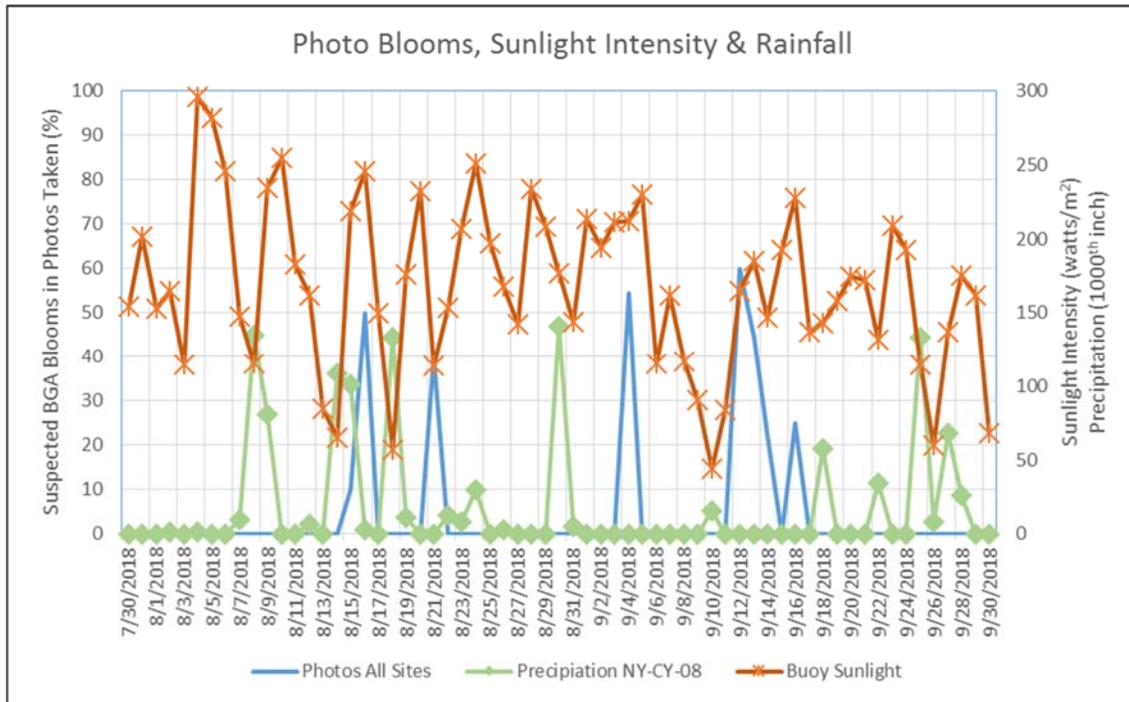
Fig. 15. Air and water temperatures measured at each site correlate nicely (above), as do daily mean dock and buoy surface water temperatures (middle top). Water temperatures appear to dip a day or two before the majority of the suspected blooms detected in the homeowner photographs (middle bottom). Finally, sunlight intensity appear to dip before a bloom then peak during the bloom. Perhaps a storm brought in cooler temperatures, introduced nutrients (runoff or sediment disturbance) and enough wave turbulence to release resting BGA from the sediments. It all facilitated a BGA bloom on the first subsequent calm and sunny day.

Dock-side air temperatures measured in this study ranged from 11.6 to 32.5°C (53 to 90°F), and averaged 24°C (75°F), and dock-side water temperatures ranged from 18.1 to 26.8°C (65 to 80°F) and averaged 23.4°C (74°F, Appendix E). Air and water temperatures correlated nicely ($r^2 = 0.8$); the air experienced larger temperature swings than the water, as expected (Fig. 15). Like wind speeds, minimal correlation was found between the weekly temperatures measured at each site and the BGA and toxin concentrations other than suspected blooms were detected when the water was above 20°C, but blooms did not develop on every > 20°C day.

Daily air and surface water temperatures were also measured by the FLI monitoring buoy. The dockside water temperatures correlated very well to the buoy surface water temperatures ($r^2 = 0.98$, Fig. 15). The shallower, nearshore sites are cooler than the offshore buoy during cooling trends and warmer during warming trends, as expected, because the docks are at shallower locations with thinner thicknesses (mass) of water to warm up or cool down.
