Status of Owasco Lake / Watershed 2022 Research

Owasco Lake Watershed Management Council
1-17-2023 Mtg

John D Halfman
Environmental Studies Program
Department of Geoscience
Finger Lakes Institute
Hobart & William Smith Colleges

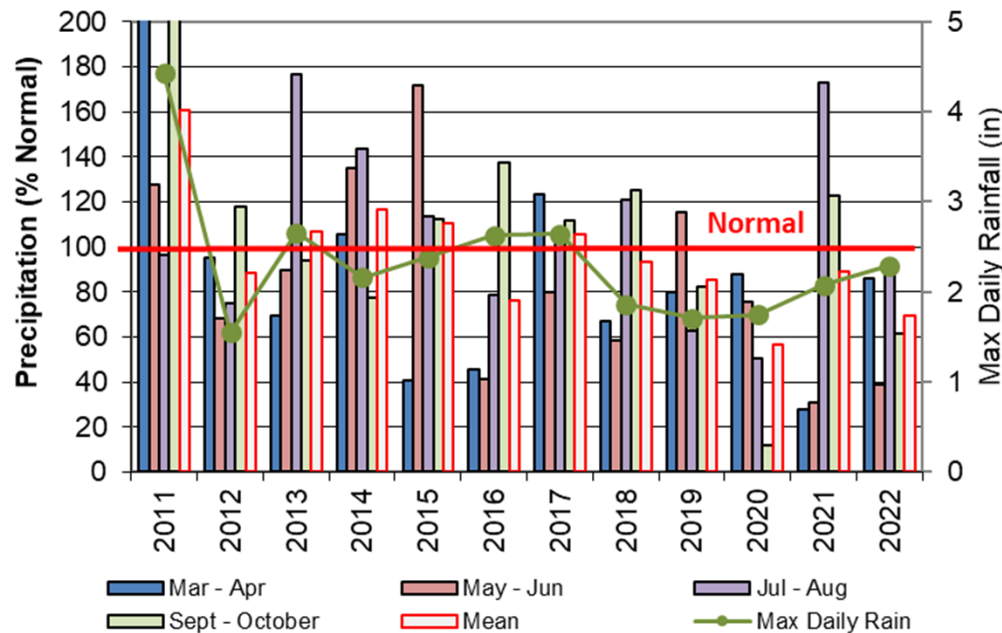
Seasonal Precipitation @ Ithaca Airport
2011-2022

Significant Regional Variability!
Especially largest events
→ Due to Global Warming

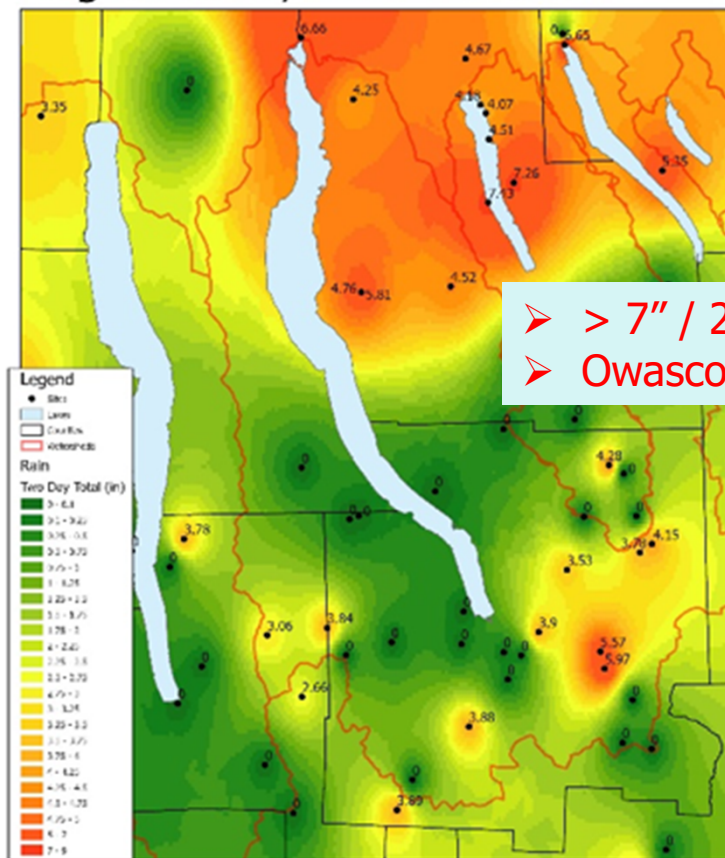
Aug 18 & 19, 2021 Rainfall

- > 7" / 24 hours
- Owasco Event

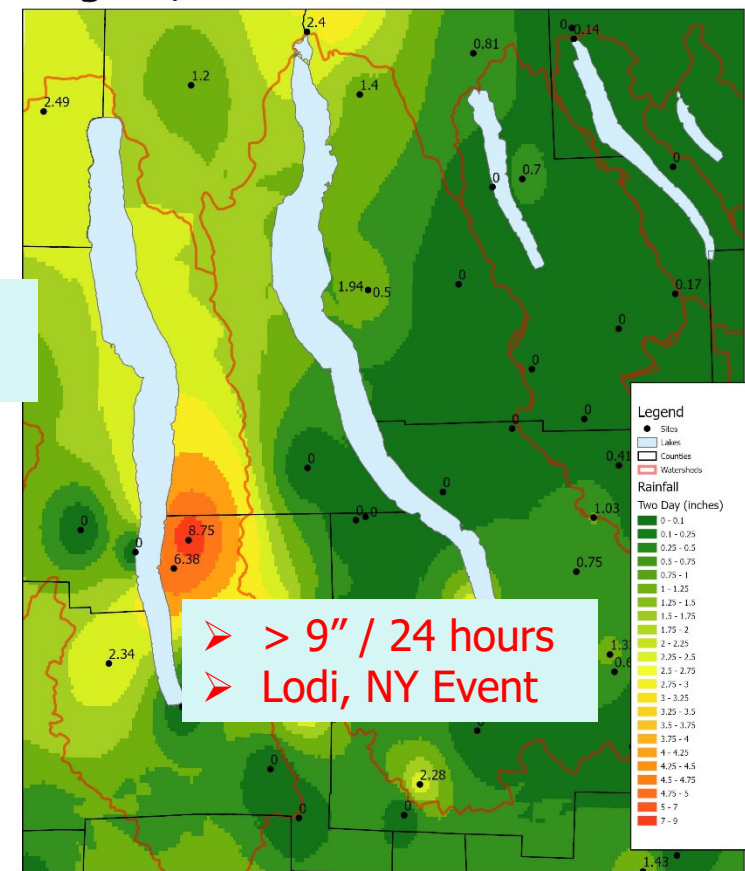
Aug 14, 2018

- > 9" / 24 hours
- Lodi, NY Event

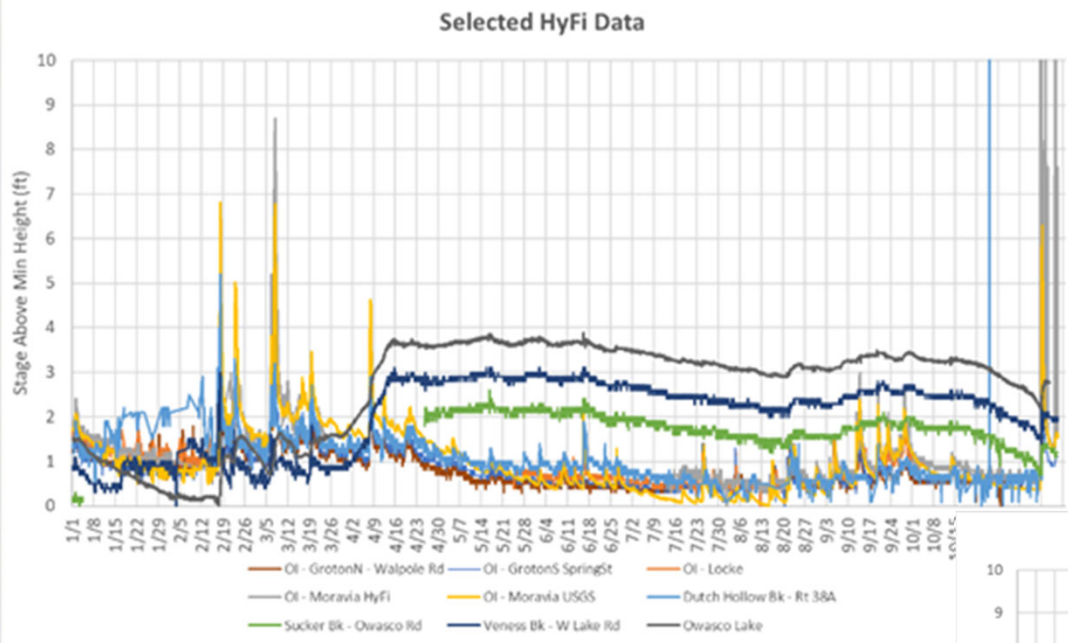
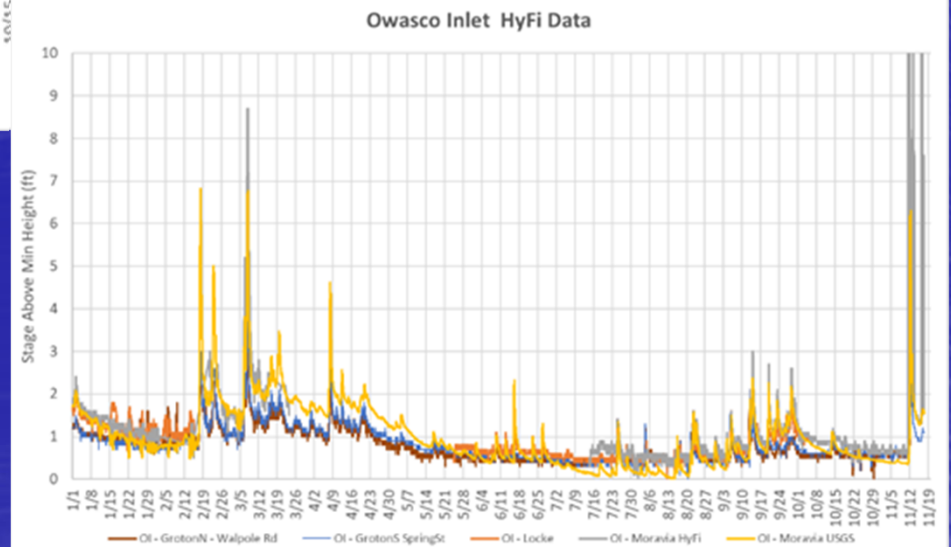
HyFi Sensors – Stream Stage

- Veness Cr & Sucker Cr Measured Lake Levels
- Otherwise HyFi records looked sound
- Single Velocity Measurement Tentative for Discharge

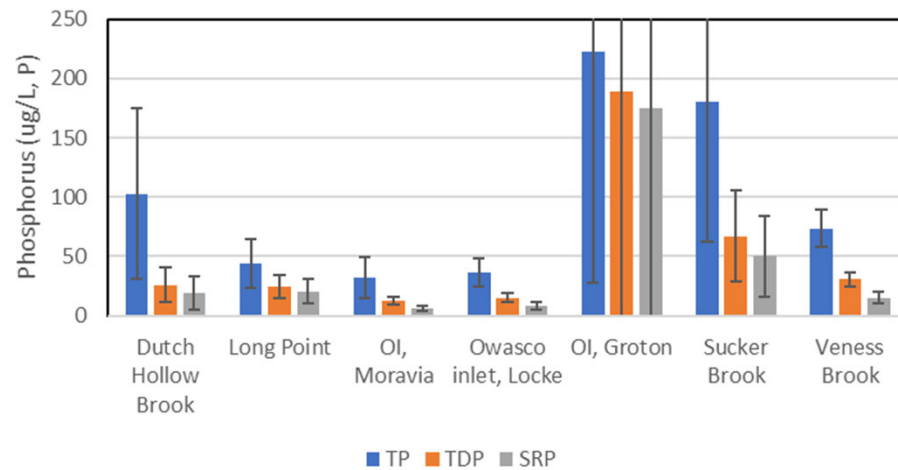
Phosphorus - Annual Averages

Similar Conc. to Past Data

P highest Groton, MWWTF Source
Diluted Down Stream

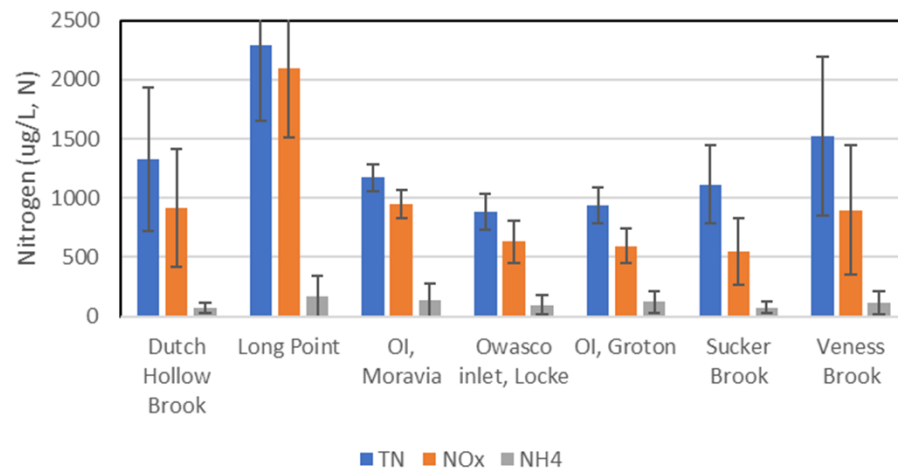
Nitrogen - Annual Averages

N Highest Long Pt, Agricultural Runoff

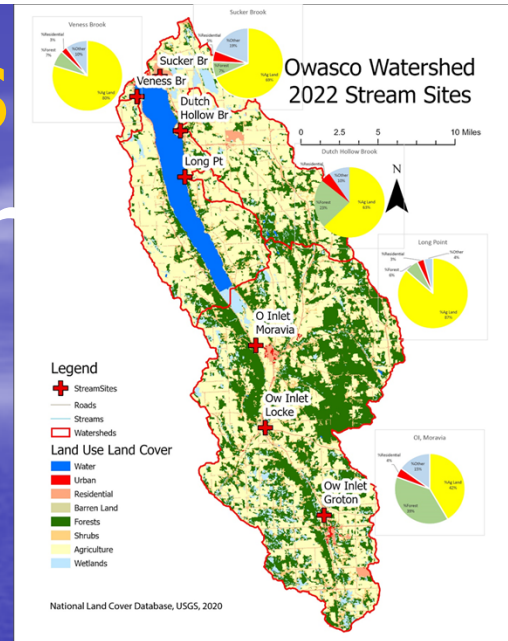
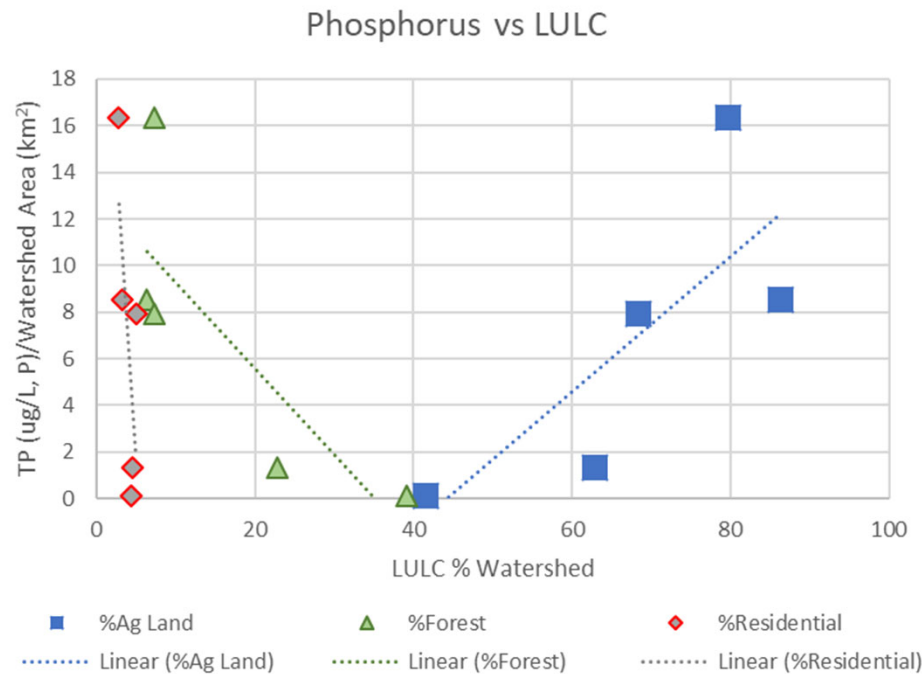
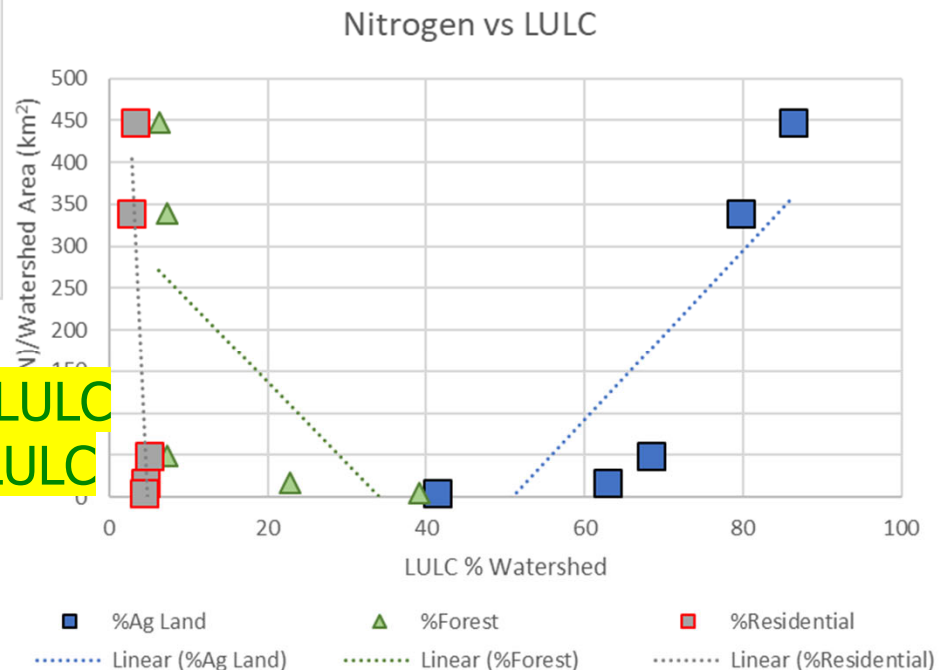
Mean Conc / Watershed Area

Nutrient & TSS Delivery ~ Agricultural LULC

Nutrient & TSS Delivery ~ 1/Forested LULC

Unclear Urban & Residential...

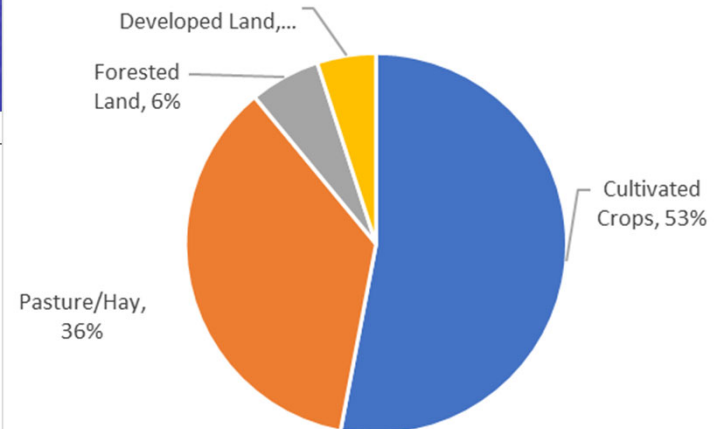
Total Phosphorus Loads

TP Loads On Per Acre Basis:
Agricultural Land >> Forests

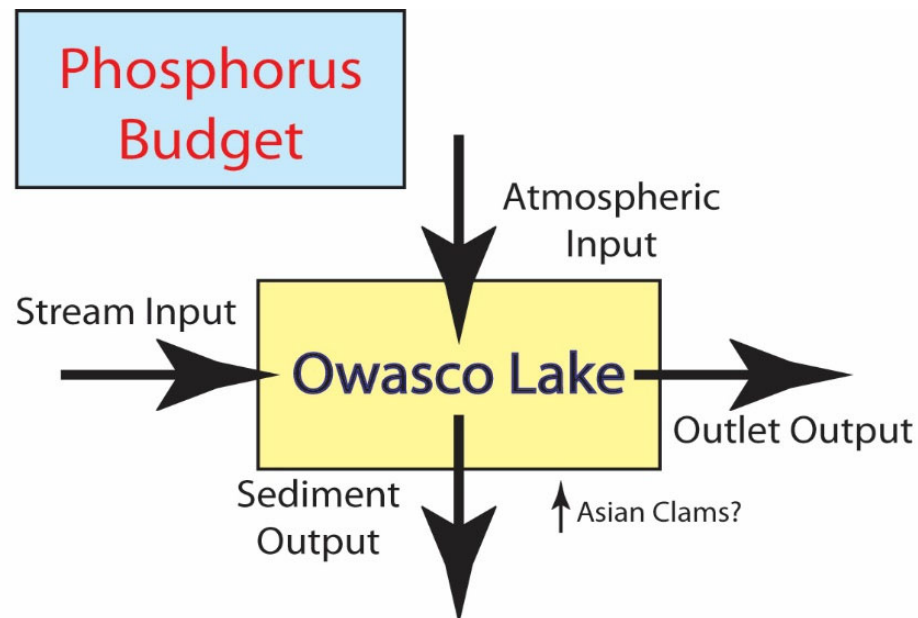
Phosphorus Budget

Inputs >> Outputs

Inputs ~ Outputs

Inputs >> Outputs
8/18 Event > 50% Load!
Future Climate?

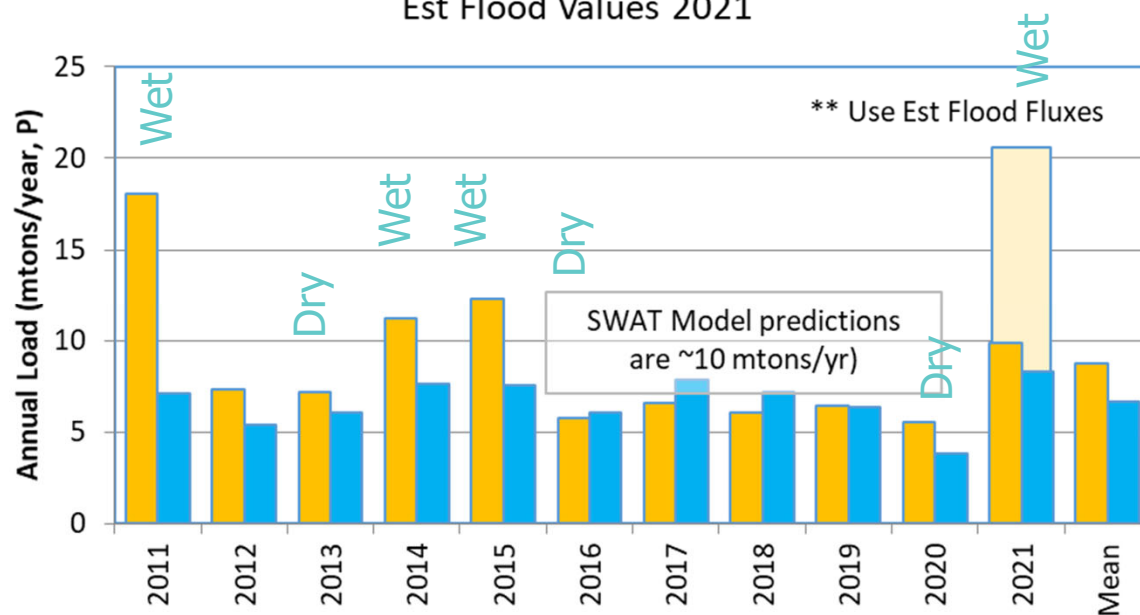
Phosphorus Estimated Inputs & Outputs

Est Flood Values 2021

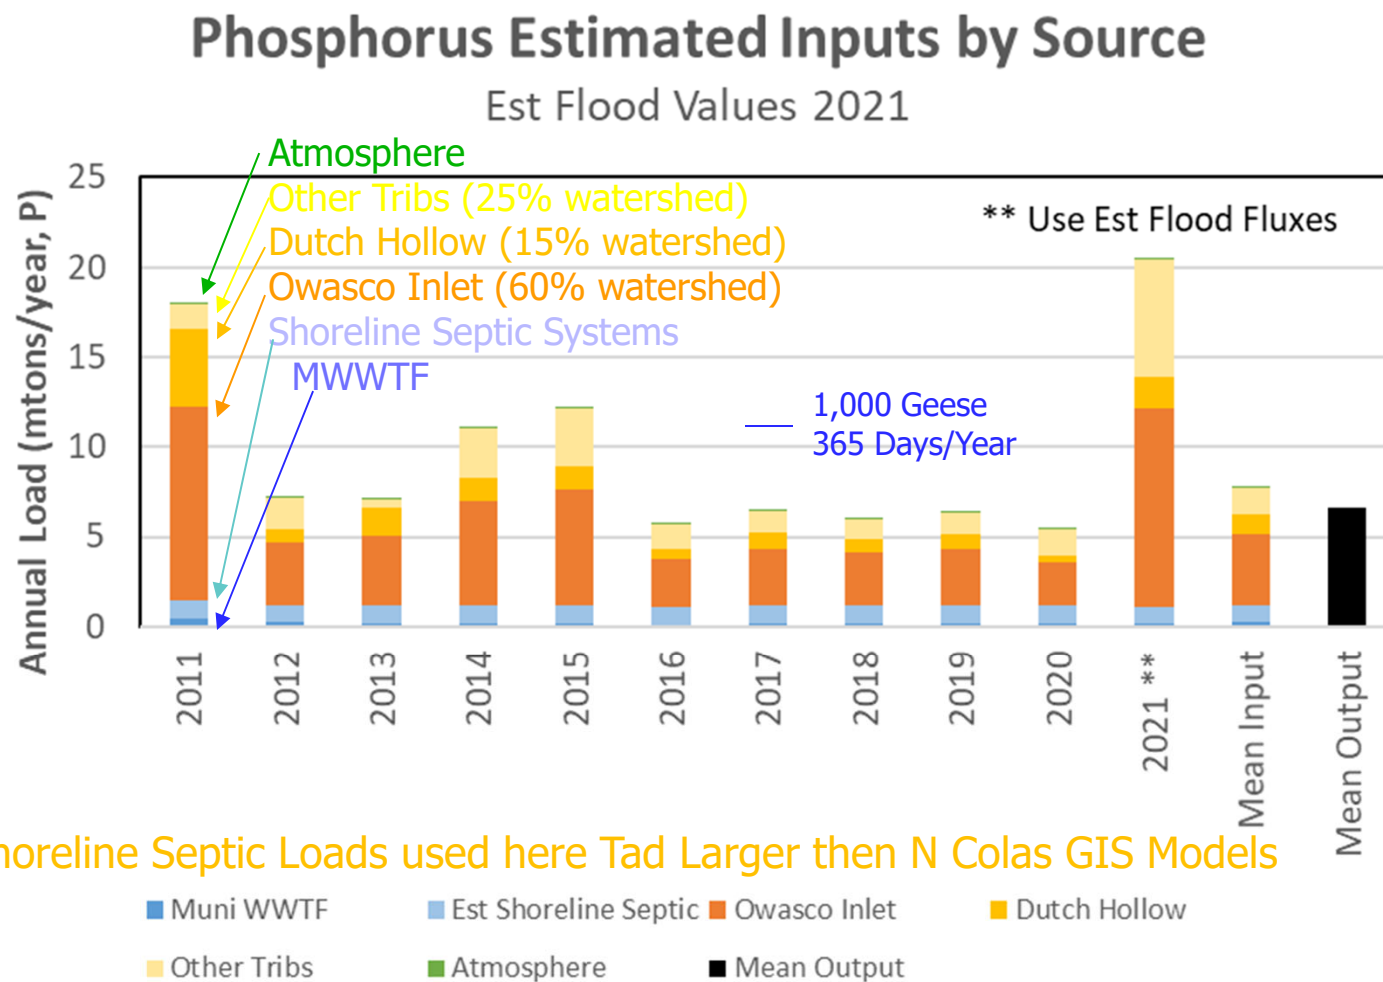
Loads by Source

Majority From Rain Events

Rainfall Varied from Year to Year

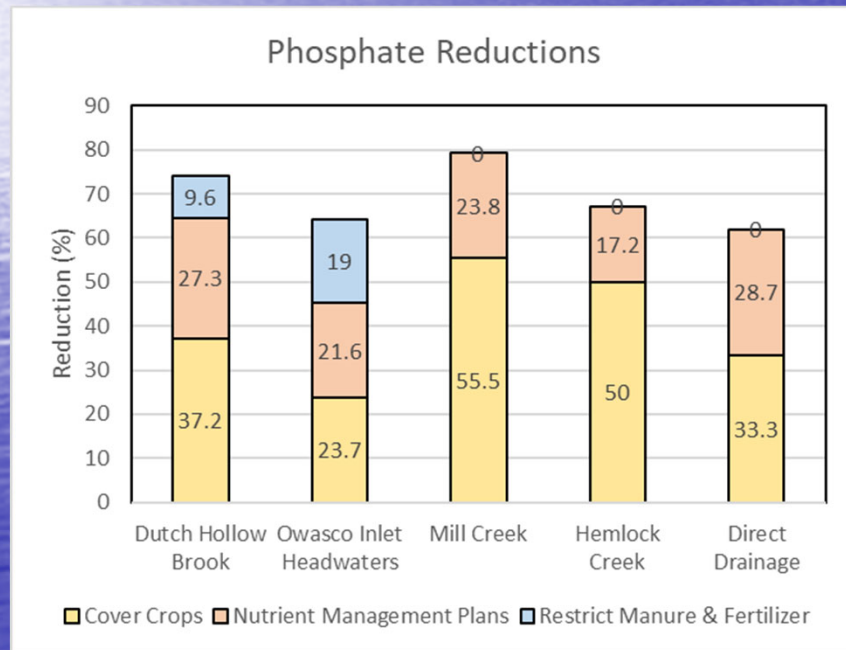
9E Plan SWAT Model Threefold TP Reduction Strategies

Three Critical Remediation Strategies:

- Winter Cover Crops
- Nutrient Management Plans
- Restrict Manure & Fertilizer Use

~60-70% P Reductions

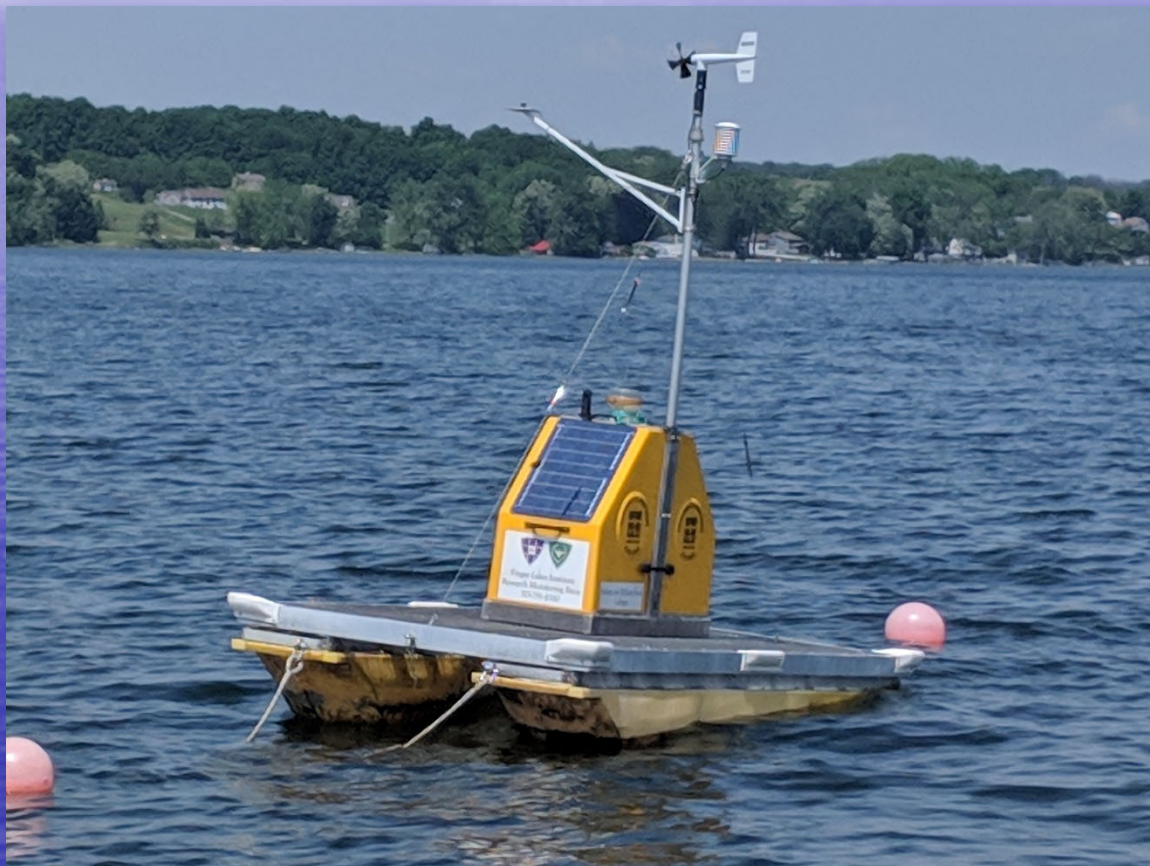
Early Season Issues Required Repairs to Buoy Floats

Patched Round Holes Found in Float Top
If noticed in future – let FLI know. Hate to lose \$150,000

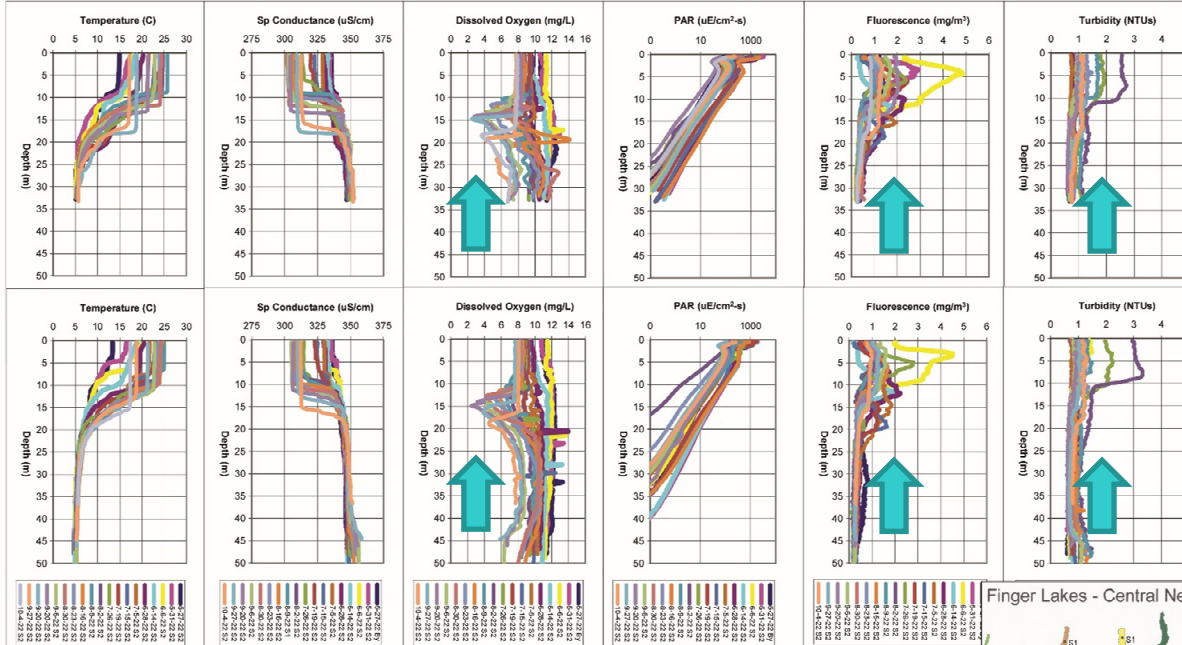
Owasco Lake 2022 Data

Near Normal Year
Spring Rains

Site 1 - 34 m
42° 52.4" N
76° 31.35" W

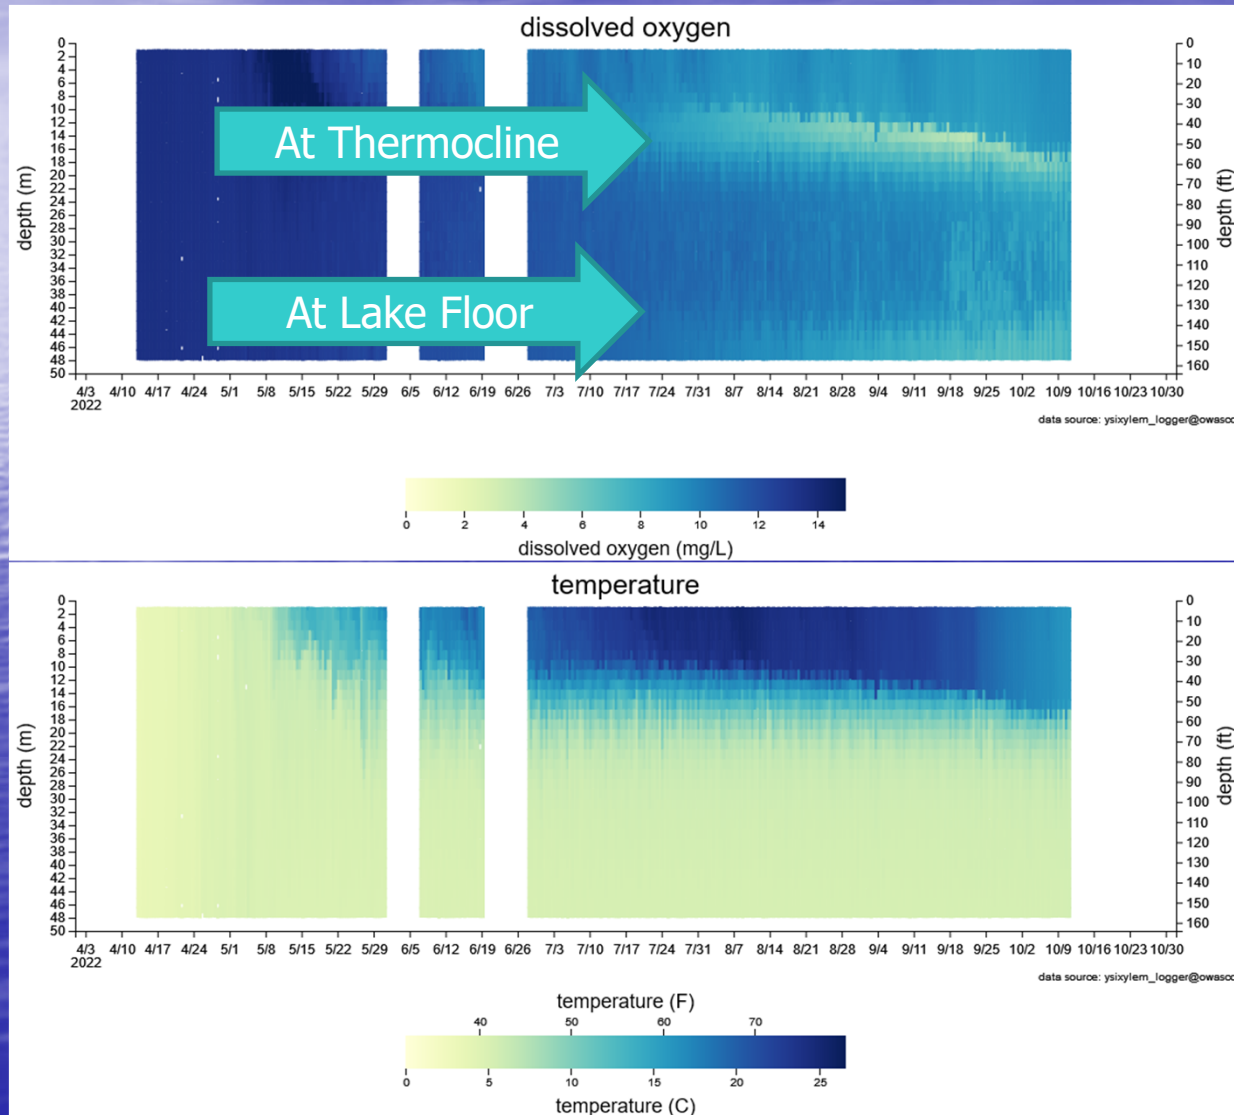
Dissolved Oxygen Depletion

Dissolved Oxygen depletion from bacterial decomposition of algal matter and other organics

Uses Dissolved Oxygen Releases Nutrients

Typically trapped in Hypolimnion

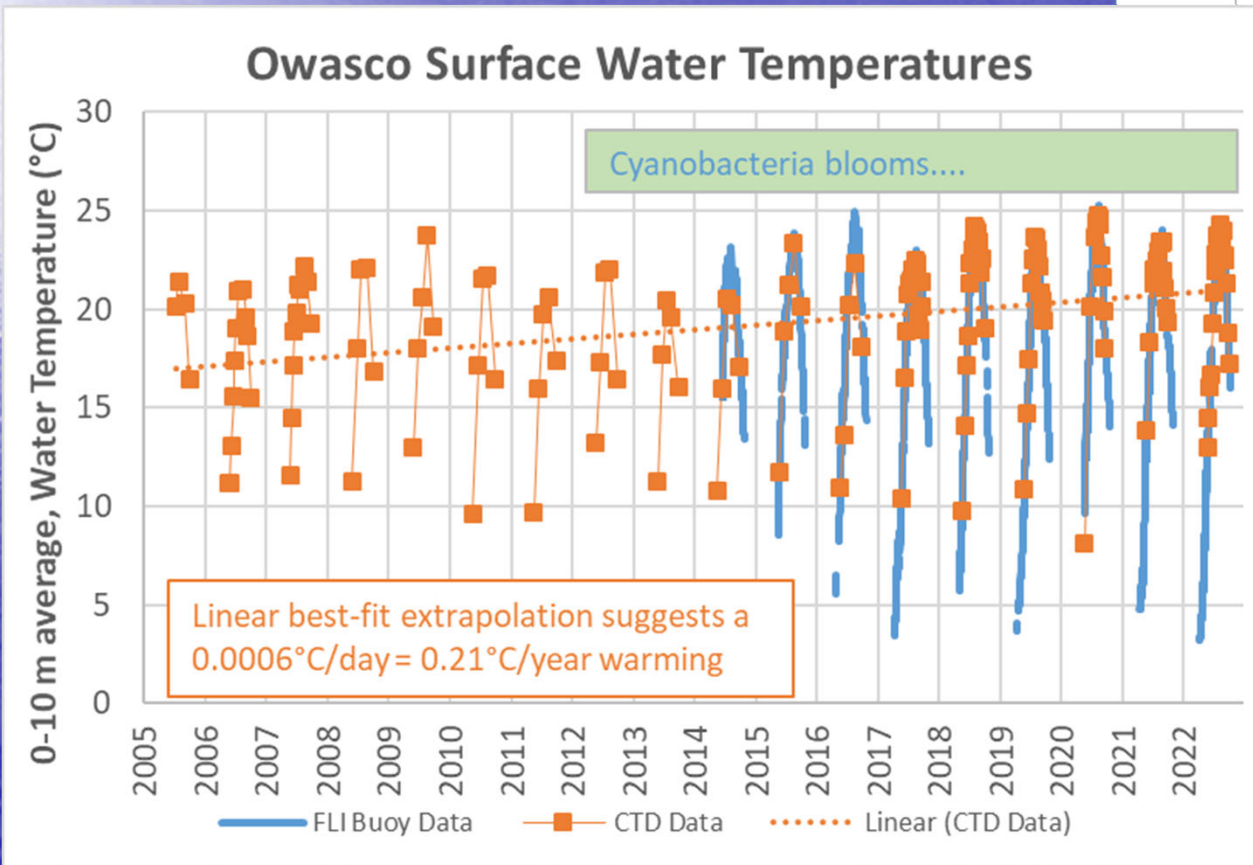
Surface Water Temperatures

Warmer Water → More HABs?

Not Perfect Match

Pushed Lake over Threshold...

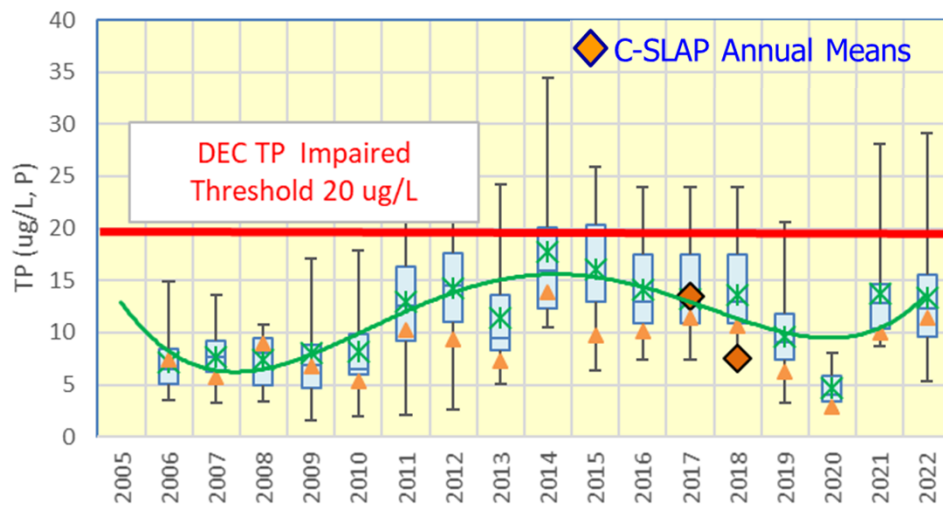
Owasco Annual Surface Total Phosphate

High TP:-

Phosphate \rightarrow 13.3 $\mu\text{g/L}$

P:N Ratio \rightarrow 1:1,000 (mass)

P: Limiting Nutrient

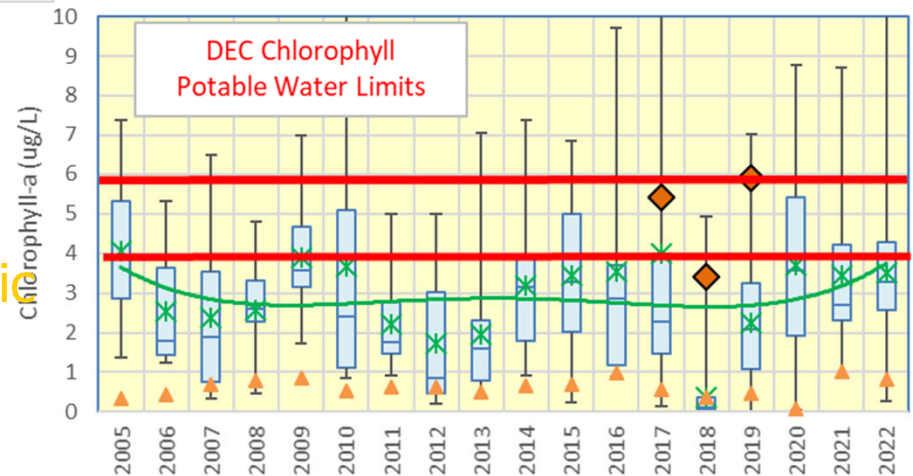
Owasco Annual Surface Chlorophyll-a

Chlorophyll a – 3.8 $\mu\text{g/L}$ Oligotrophic

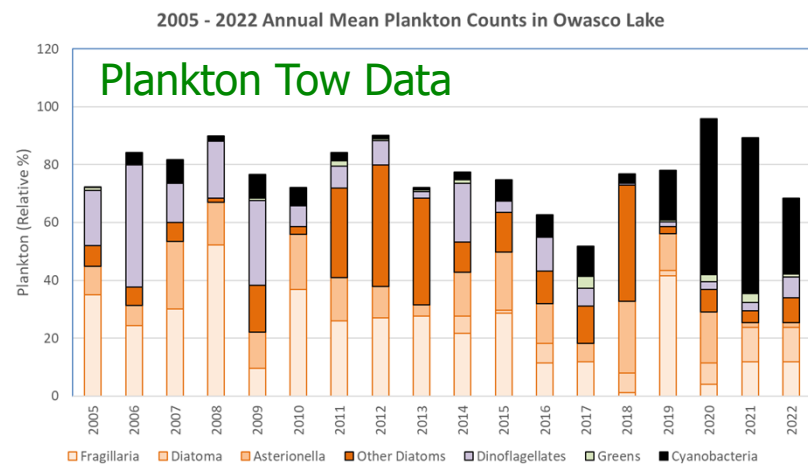
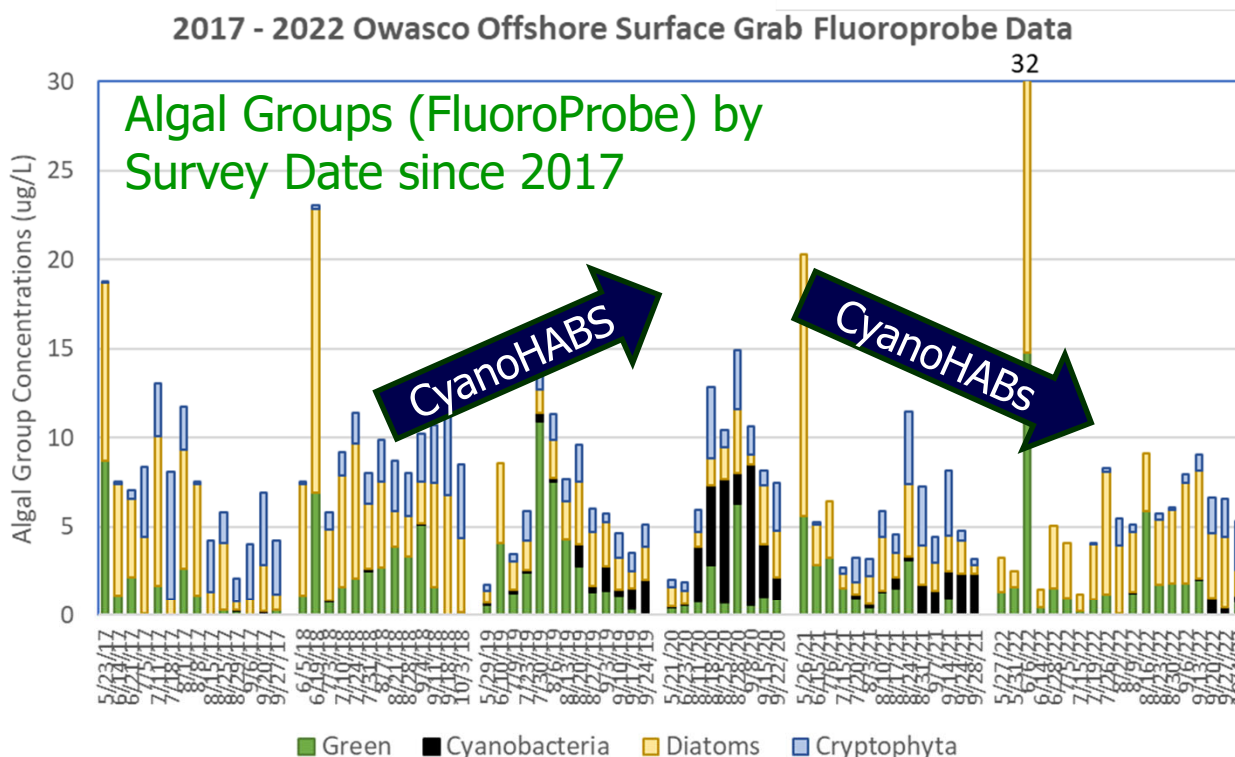
Annual Average
Plankton

FluoroProbe Measures

Brown
Diatoms
Green
Green Algae
Blue-Green
Cyanobacteria
Red
Cryptophytes
Yellow Subs.

HABs less
Dominant
August -
November

Decrease in
BGA compared
to previous
years

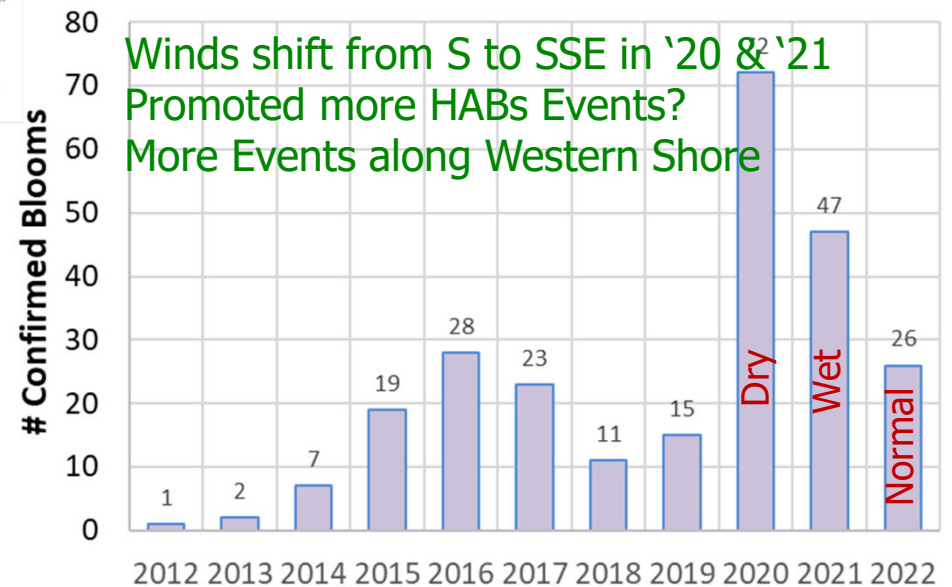
Cyanobacteria Blooms - Owasco Lake

Winds shift from S to SSE in '20 & '21
Promoted more HABs Events?
More Events along Western Shore

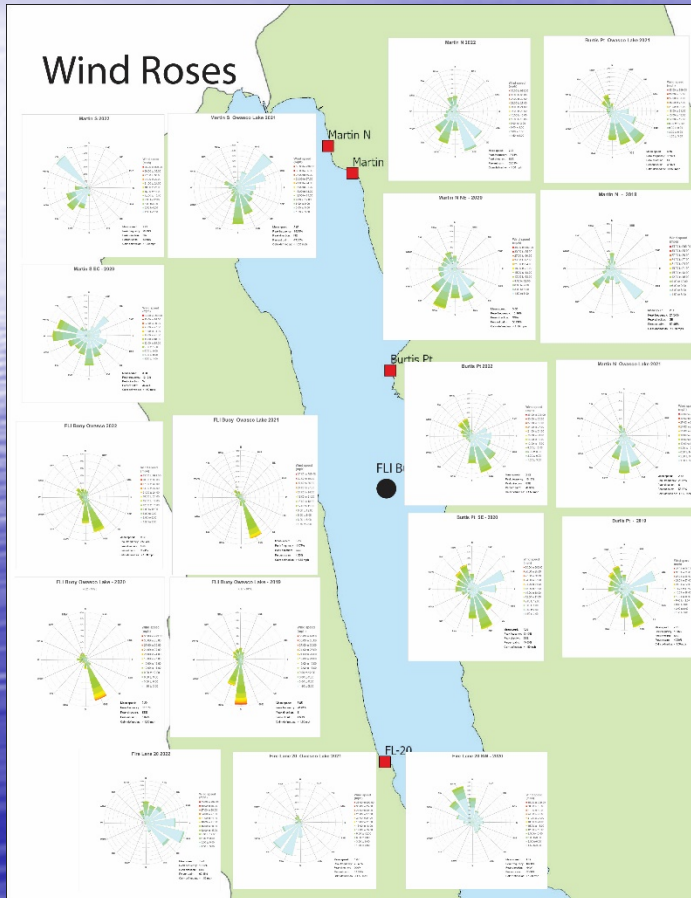
Wind Roses

Dock Wind Directions
Different!

Wind Speeds Slower!

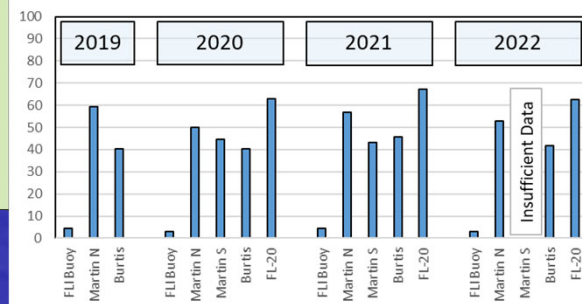
Owasco % Calm Conditions (<1.5 mph)

Nearshore Winds***
Decrease in Speed
Altered Directions
***Reason for
Bloom in One Area
BUT Not Others?

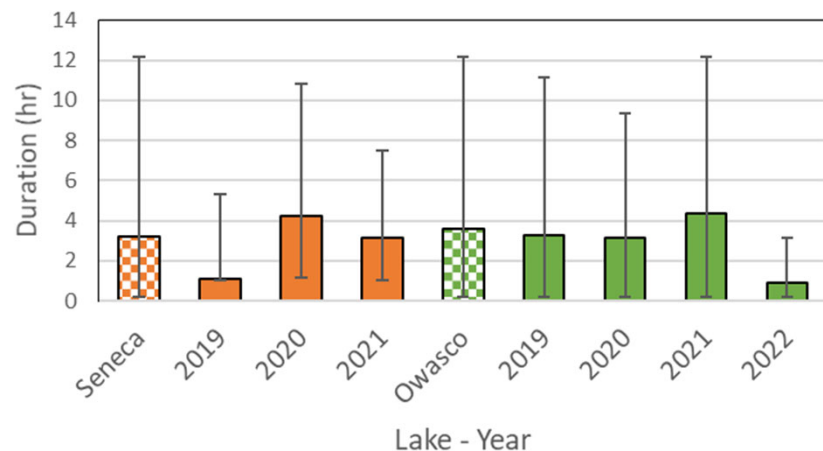
Automatic Cameras

Photo Every 10-minutes

Bloom Duration 2-4 Hours

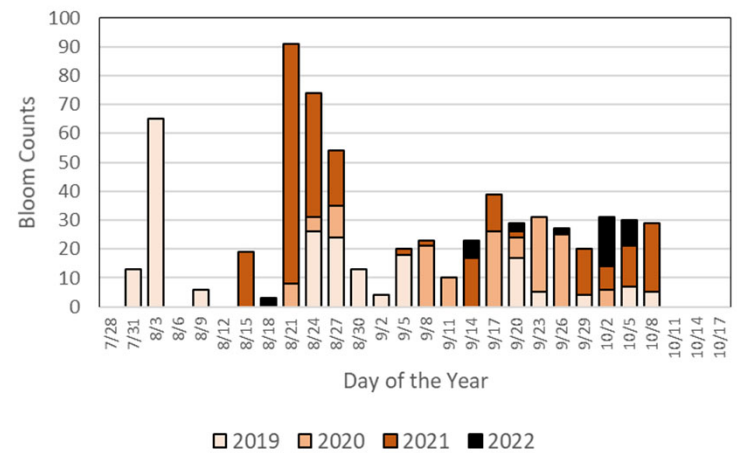
Bloom Date - Owasco Aug-Oct

Blooms are Spatially Sporadic
At 12 Monitored Sites

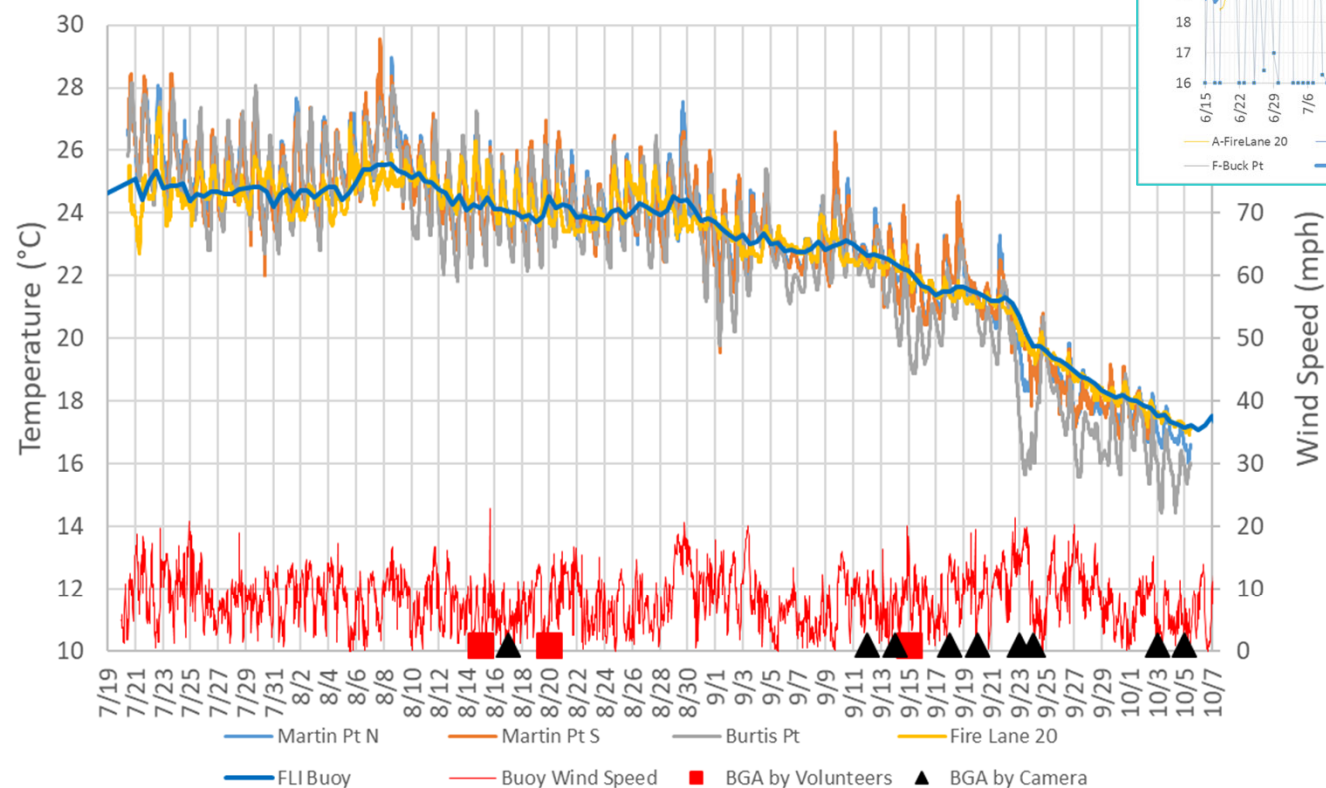
Owasco Docks & FLI Buoy (1 m) Temperatures (°C)
Buoy Wind Speed

Water Temperature Dips

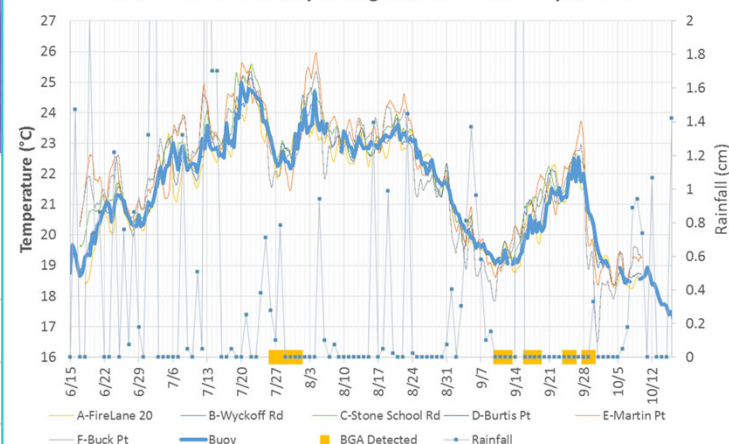
2017 Owasco Lake Daily Average Surface Water Temperatures

No Major Temp Dips
Fewer Blooms?

HABs After Temperature Dips? → Nutrient Source?

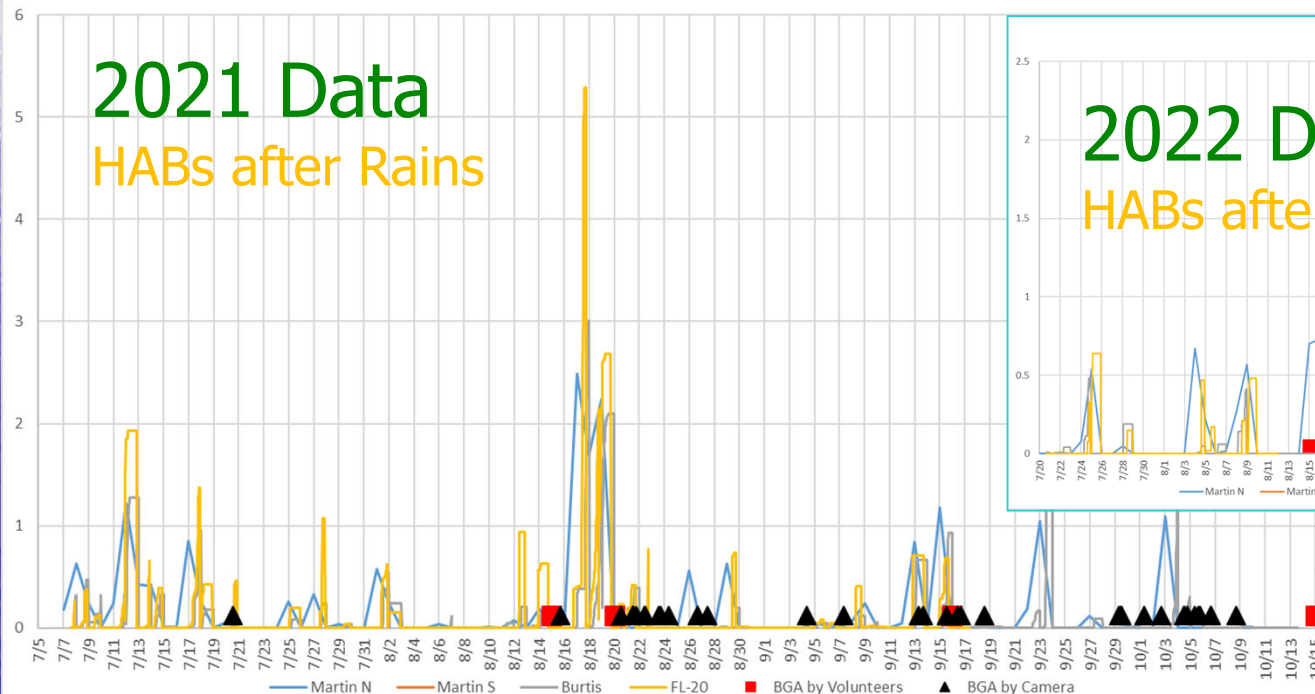
2021 Data
HABs after Rains

Daily Rainfall (in)

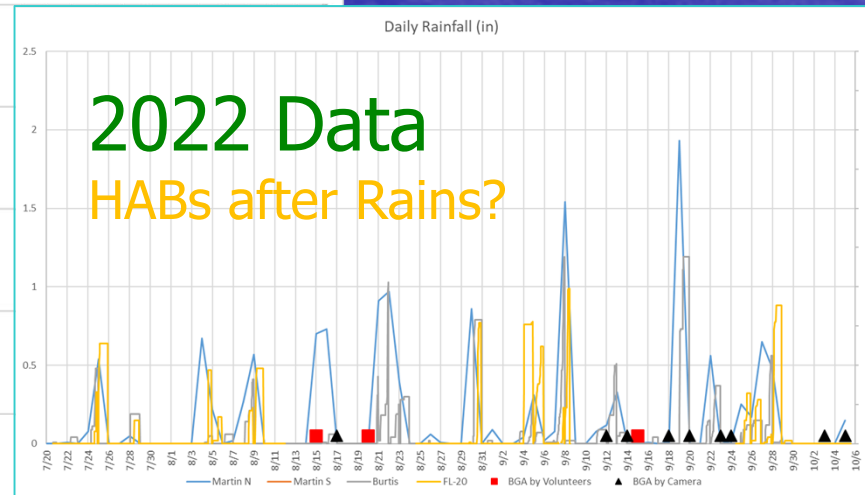
2022 Data
HABs after Rains?

Daily Rainfall (in)

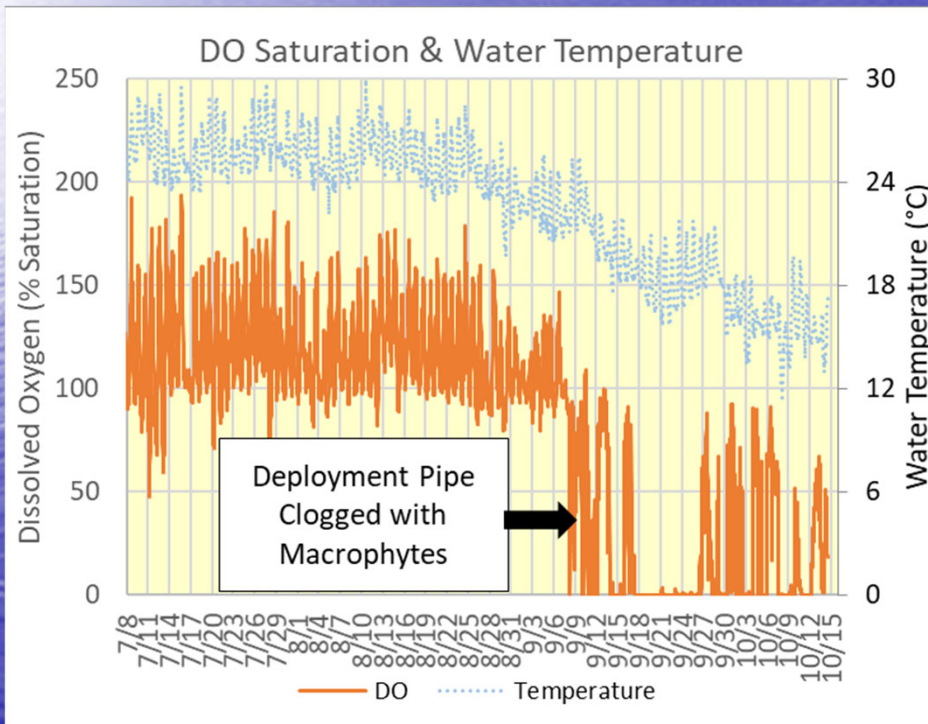
In-Situ Aqua Troll 600

Dock WQ Sondes

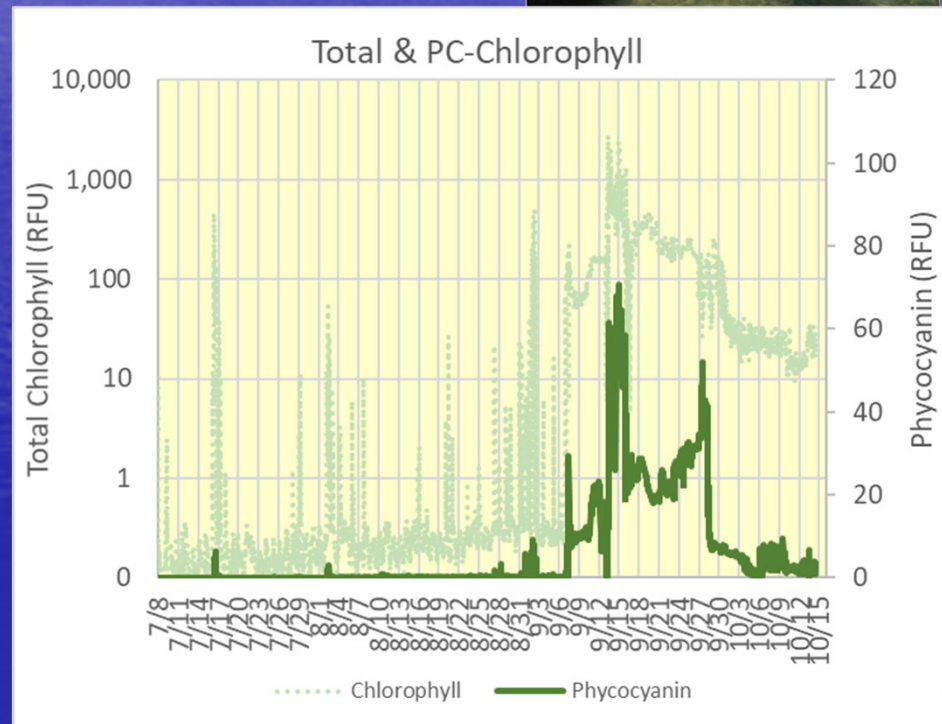
Macrophyte Decomposition - Anoxia At
Martin Pt inside Pipe → → →

Induced Cyanobacteria Bloom inside Pipe
