Status of Owasco Lake / Watershed 2022 Research

Owasco Lake Watershed Management Council
1-17-2023 Mtg

John D Halfman
Environmental Studies Program
Department of Geoscience
Finger Lakes Institute
Hobart & William Smith Colleges

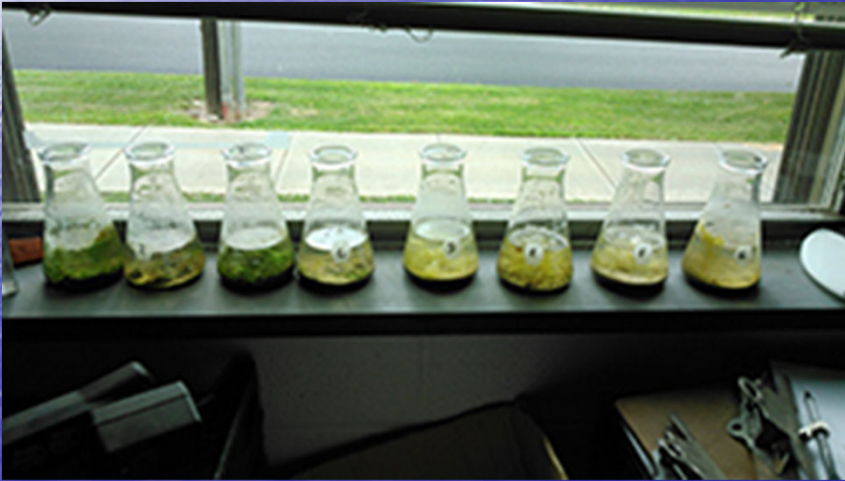
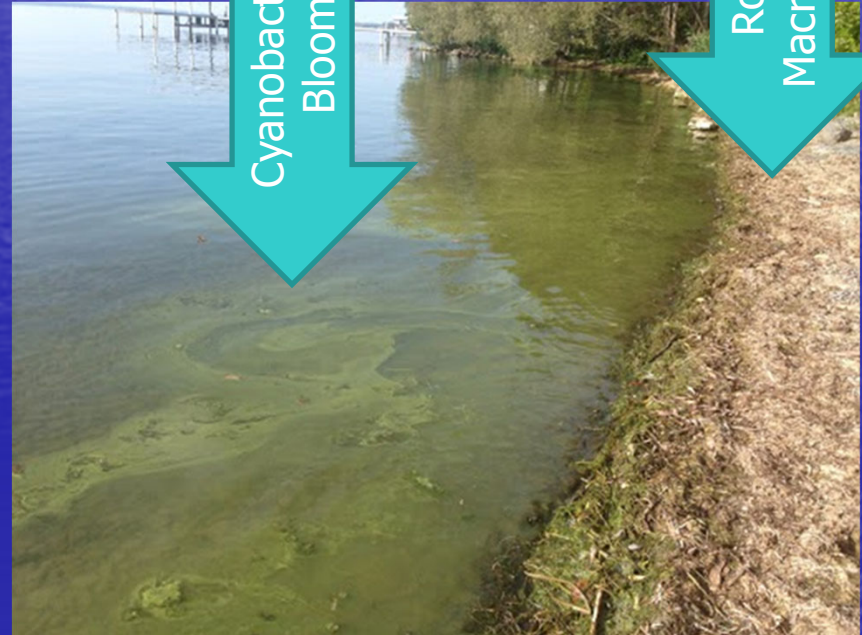
Blooms from Mud Samples

Blooms from Decaying Macrophytes

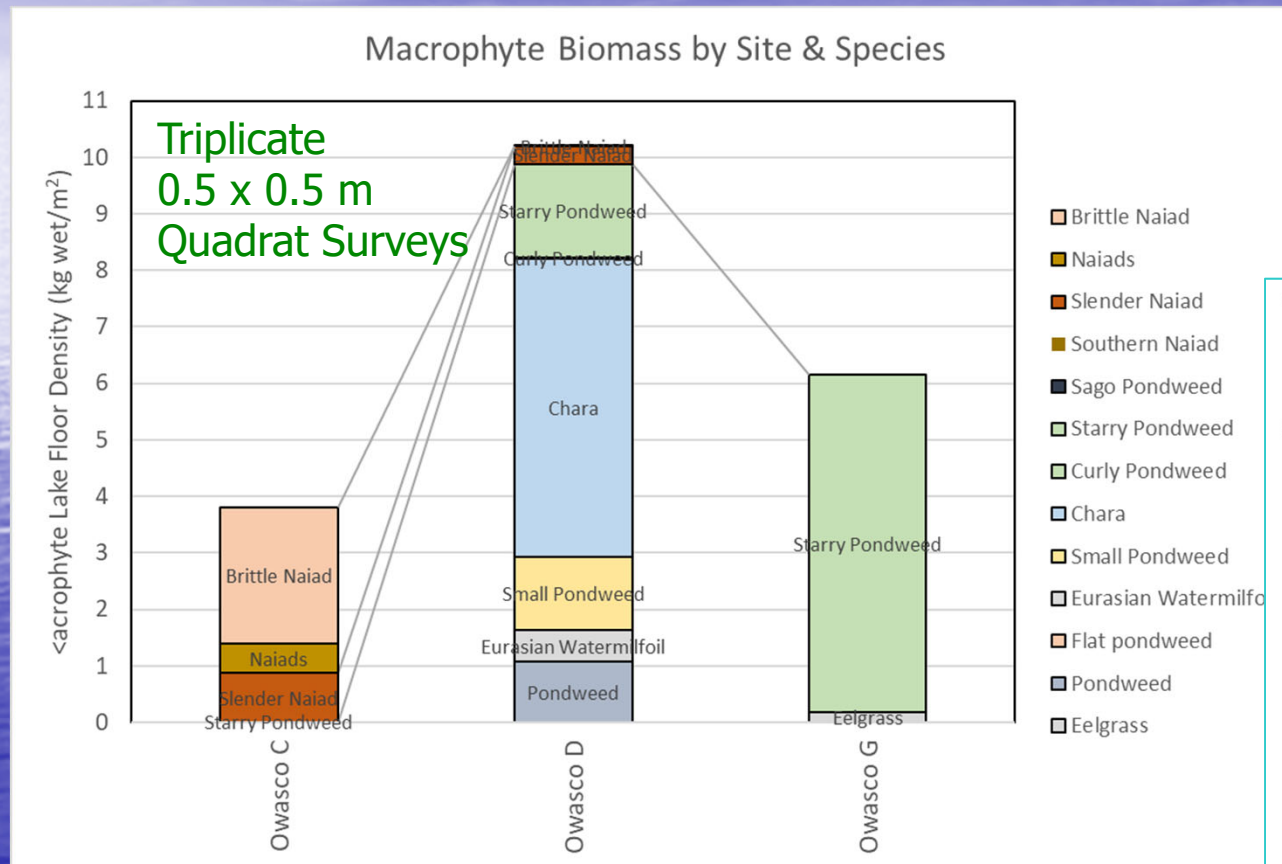
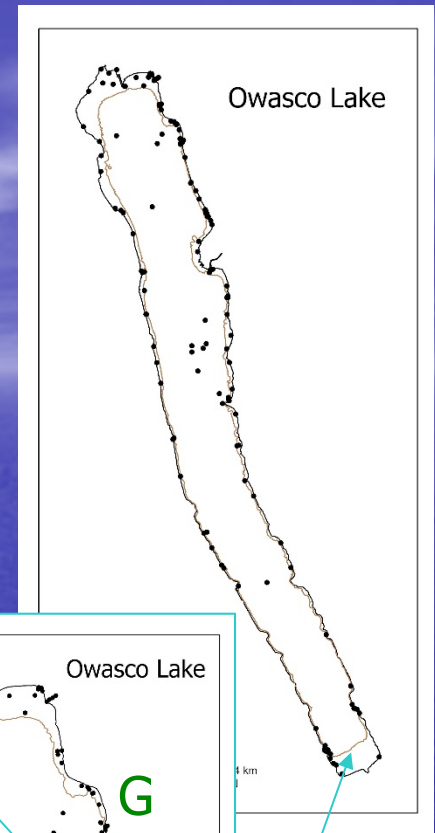
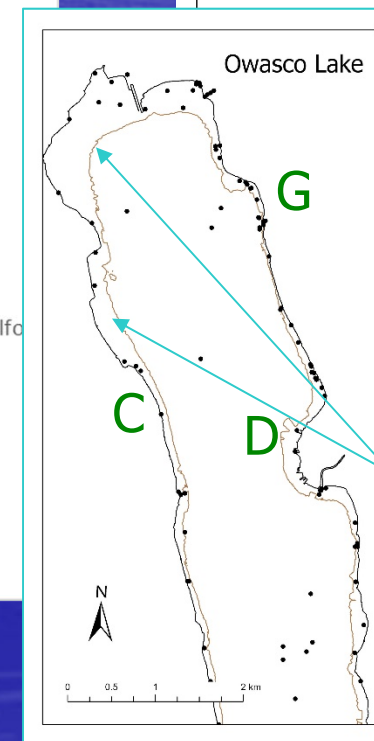
Nearshore Macrophyte Biomass – 2021 Data

4 m
Contour

More
shallow
water in
North &
Burtis Pt

Sufficient Biomass to Supply HABs Along Shoreline
More Shallow Water along Northern Shorelines
Dominant Winds blow Rotting Macrophytes towards North & East Shores
